FINAL REPORT OF INVESTIGATION
TO THE DIESEL EMISSIONS EVALUATION PROGRAM
(DEEP)

NORANDA INC. - BRUNSWICK MINE
DIESEL PARTICULATE FILTER
(DPF)
FIELD STUDY

OCTOBER 2004

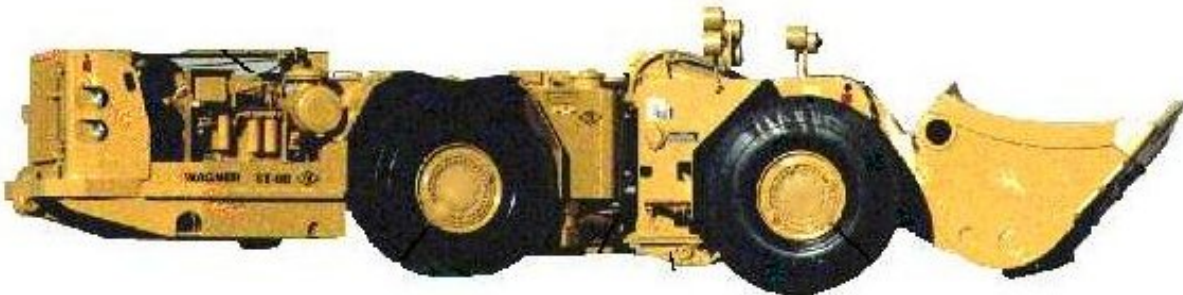
Figure 1 - Atlas Copco Wagner ST8B Scooptram®

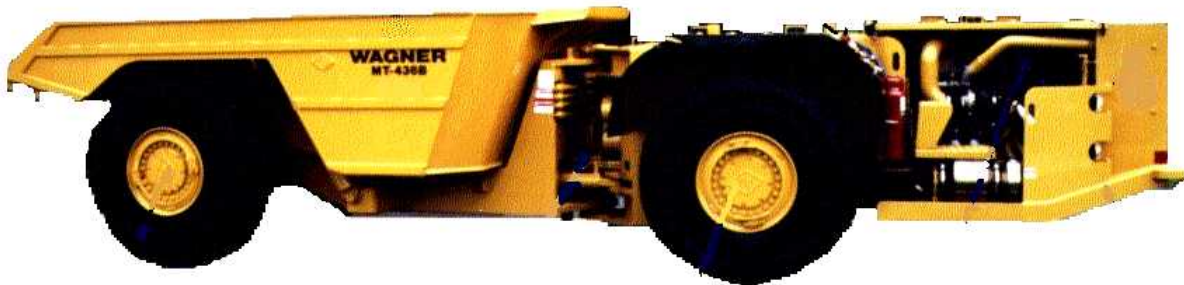
Figure 2 – Atlas Copco Wagner MT436-B Haulage Truck

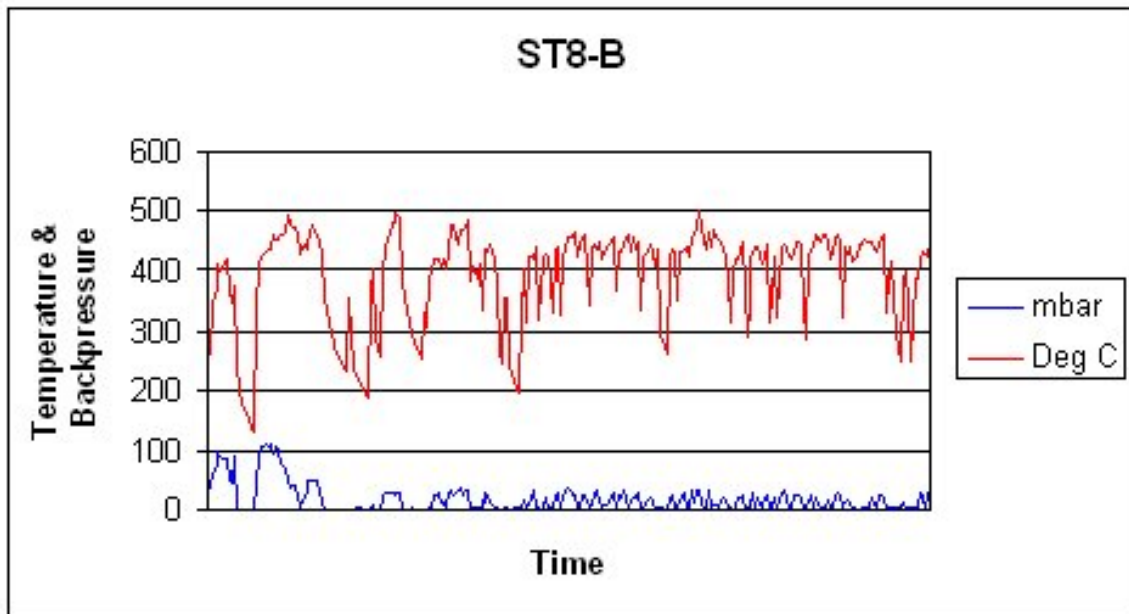
Figure 3 - ST8-B Scooptram® Duty Cycle

These duty cycle parameters allowed manufacturers to select and optimize DPF systems for the applications with respect to the exhaust temperatures and other features of vehicle operation. Figures 3 and 4 show a portion of the data that was presented to the DPF manufacturers. The traces in red at the top of the charts are exhaust temperatures from two points on the exhaust system and the blue trace at the bottom is exhaust backpressure. The chart in figure 3 demonstrates the short tight cycles with high exhaust temperatures typical of the LHD application. The chart in figure 4 shows the longer cycles with lower exhaust temperatures typical of the haulage truck application.

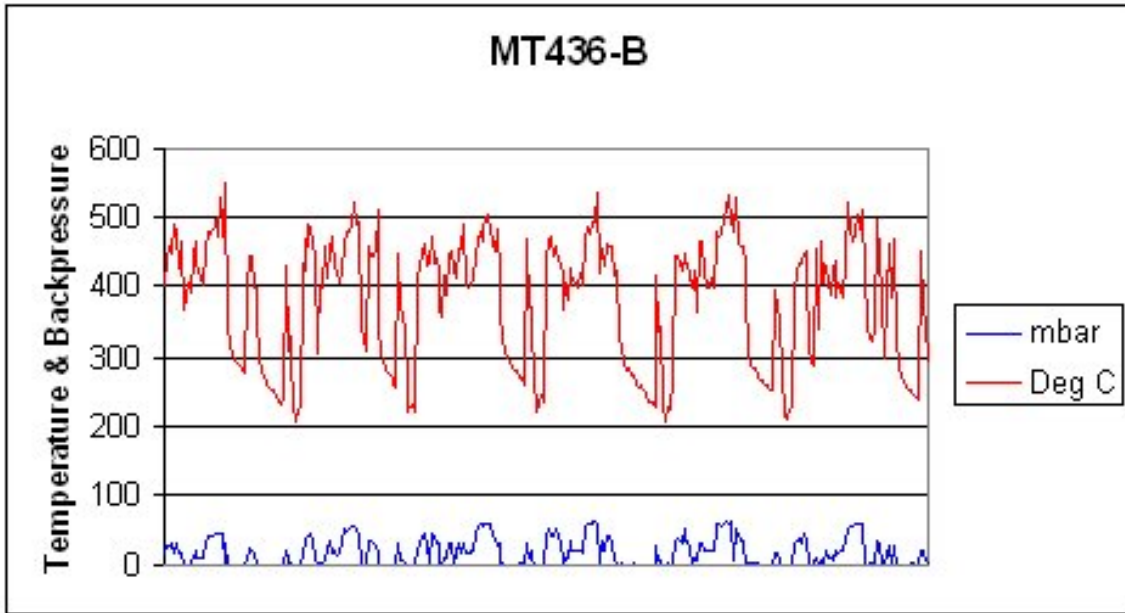
Figure 4 - MT436-B Truck Duty Cycle

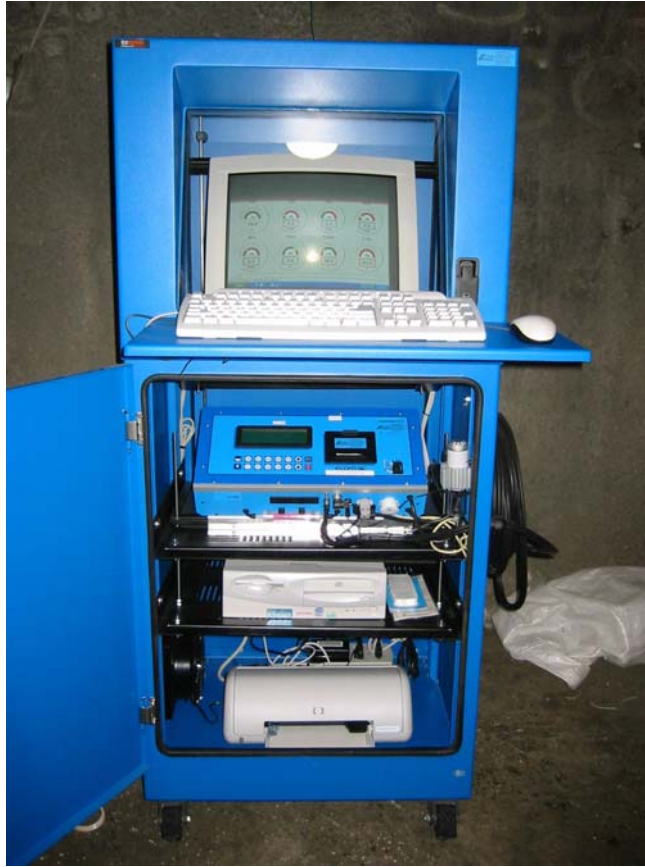
Figure 5 - UGAS Emissions Testing System

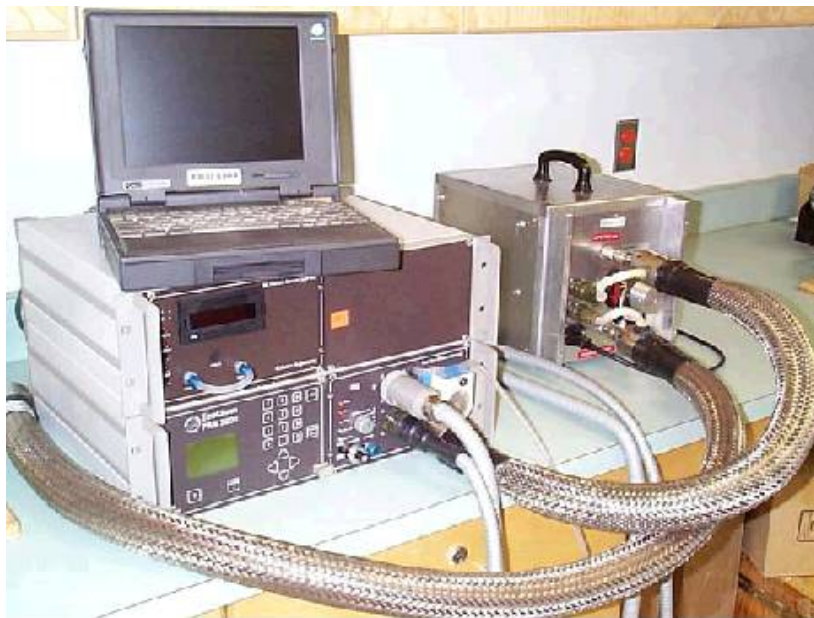
Figure 6 - NanoMet Diesel Particulate Analysis System

The NanoMet Diesel Particulate Measurement System (Matter Engineering AG, Wohlen, Switzerland) shown in Figure 6 was acquired by CANMET for the purpose of conducting periodic assessments of performance of diesel particulate filters. Although sold as a portable field instrument, the NanoMet is essentially a laboratory grade instrument modified for field measurements [Kasper et al. 2001]. The NanoMet was found to be a sophisticated but complex instrument that required a trained operator.

The combination of the two sensors with the heated sampling and dilution permits differentiation between solid and liquid fraction of the sampled aerosols. The diffusion charging particle sensor uses corona discharge to non-selectively charge solid and liquid aerosols. The instrument characterizes the particles in terms of the active surface. The PAS 2000 is a photoelectric real-time aerosol sensor. The aerosol is photo charged at the inlet to the sensor using an exciter lamp. Since only aerosols with solid core can be efficiently charged using photoemission there is belief that the output of the instrument is strongly correlated to the elemental carbon (EC) fraction in the DPM samples. The instrument has quick response time and wide particle size range. The PAS 2000 proved to be a more reliable and consistent instrument for assessing penetration and filtration efficiency of the DPF systems than the DC. No absolute values of particle concentrations were acquired in the testing with the Nanomet and calculations of filtration efficiencies were based only on the PAS 2000 values.

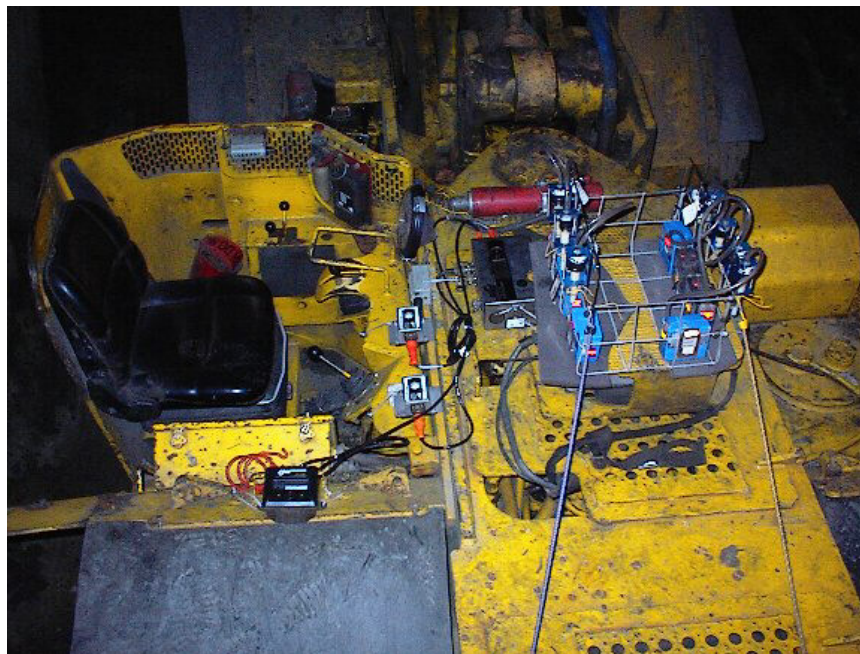
Figure 7 - RCD and NIOSH 5040 Operator DPM Sampling Trains

The NIOSH 5040 method [NIOSH Manual for Analytical Methods, 1999] uses the same sampling train as above except for the addition of a size impactor between the cyclone and cassette to block particles greater than 0.8 microns, the usual cutoff point for diesel and non-diesel particles. The sampling pump for this method is calibrated to 2 litres per minute. Samples are acquired on quartz-fiber filters in the cassettes. Analysis is performed at a laboratory by first using a punch to remove a 1.5 cm^2 cutout from the sample filter. The cutout is analyzed with an instrument that uses temperature and atmosphere control while measuring optical transmittance of the sample. Analysis is done in two stages with speciation of organic and elemental carbon defining a “split” between the two as shown in figure 8. The first stage of the analysis defines organic carbon evolved in a helium atmosphere at a temperature stepped to 850° C . The second stage defines the elemental carbon split with an oxygen-helium atmosphere at a temperature stepped to 940° C . This is the same analysis method used to calculate the values from the undiluted samples with the Ecom probe mentioned in the previous section.

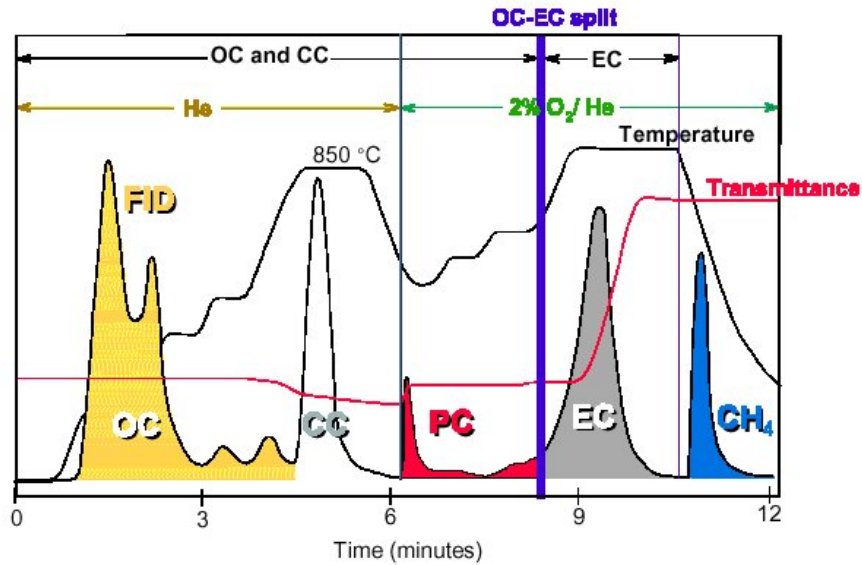
Figure 8 - Method 5040 Analysis Example

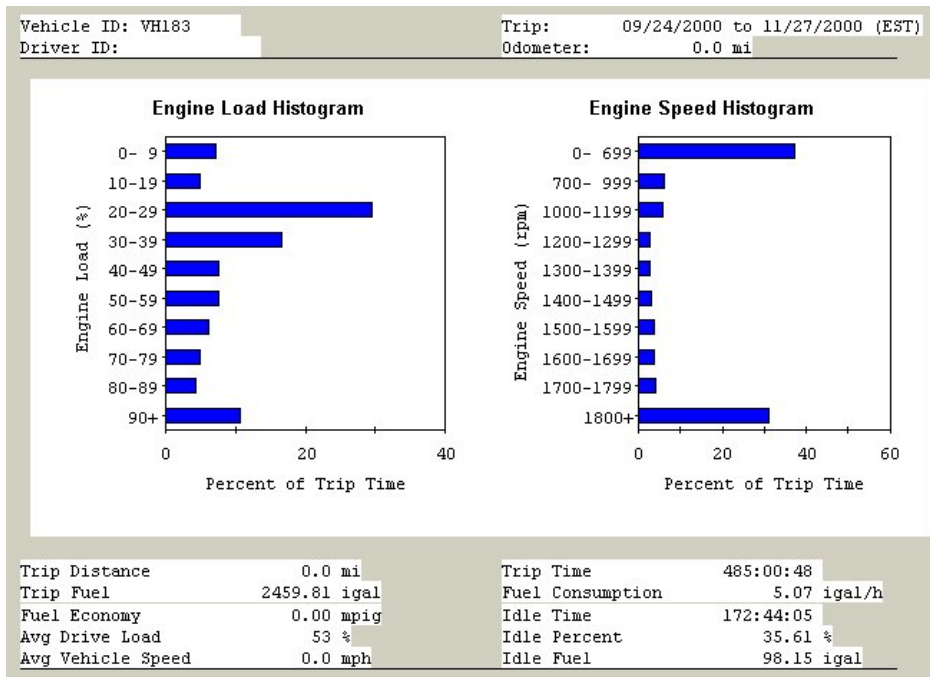
Figure 9 - DDEC Reports Engine Operating Statistics

The four vehicles used in this study were powered with Detroit Diesel electronically controlled (DDEC) engines. The engine control module (ECM) computer onboard the tested vehicles provided data on operating hours, idling hours, fuel consumption, and engine operating profiles with incremental engine speeds and loads over test periods (see Figure 9). This data proved to be the very valuable and accurate for establishing operating trends on the tested vehicles.

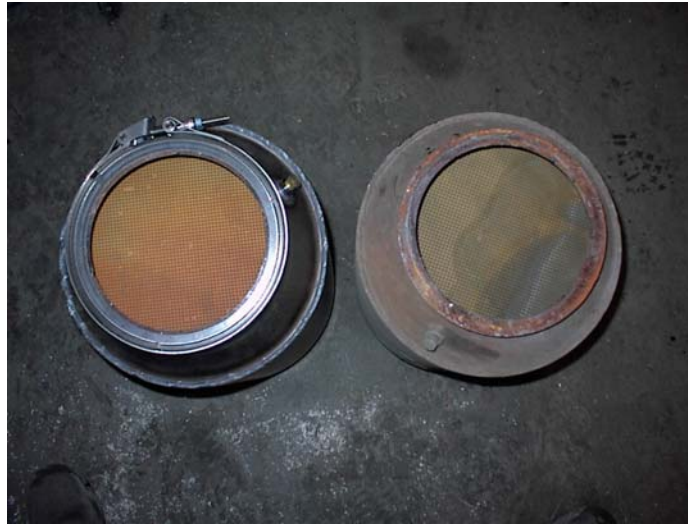
Figure 10 - ECS CatTrap Ceramic Monoliths

One of the DPF systems presented by Engine Control Systems (ECS) was chosen for one of the LHD applications. The design was selected because of its simplicity and proven reliability. Two ceramic Cordierite EX-80 monoliths as shown in Figure 10 were mounted horizontally between inlet and outlet manifolds of the DPF system. Ceramic filter monolith technology from Corning has been proven to be durable in use in mines since the 1980's. To secure regeneration of the DPF elements during the duty cycle of the LHD the monoliths were wash coated with a base metal catalyst. The coating was designed to lower regeneration temperatures without increasing gaseous emissions, in particular NO₂. The system was designed as a fully passive system. The regeneration of the system should occur during the typical LHD operating cycle and was completely transparent from the operator's perspective. ECS assigned the product name of CatTrap to the system and to which it is herein referred in this report.

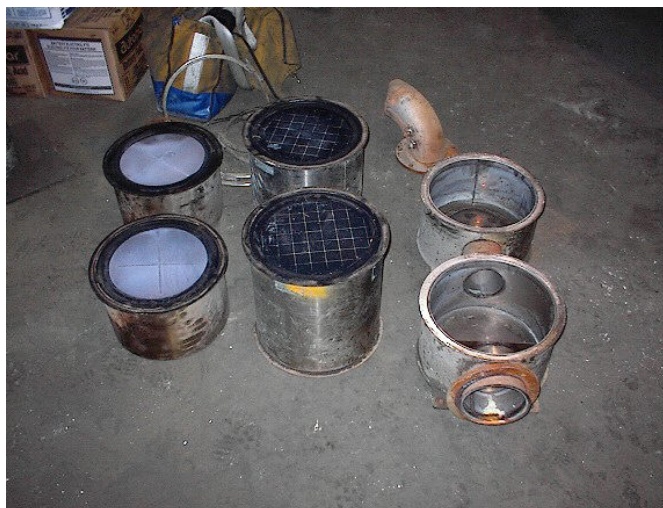
Figure 11 - ECS Octel DPF Components

A second system proposed by ECS was chosen for application on an MT-436B truck. The DPF system shown in Figure 11 was a modified ECS Unikat Combifilter design which used twin K18 silicon carbide filter monoliths and canisters, but substituted a catalytic converter (DOC) above each monolith section instead of the electric heater assemblies normally mounted in the upstream housings. The silicon carbide monolith technology has a proven track record for durability and higher resistance to thermal stress than Cordierite ceramic materials. A fuel-borne catalyst was used with the system to ensure regeneration of filter elements at the lower exhaust temperatures characteristic of relatively cold duty cycles observed for the haul trucks. The fuel-borne catalyst was supplied by Associated Octel Limited under the product name of Octimax 4804. The active components of this catalyst are iron and strontium. The product was proven through the research projects conducted in Europe [Vincent et al. 2000].

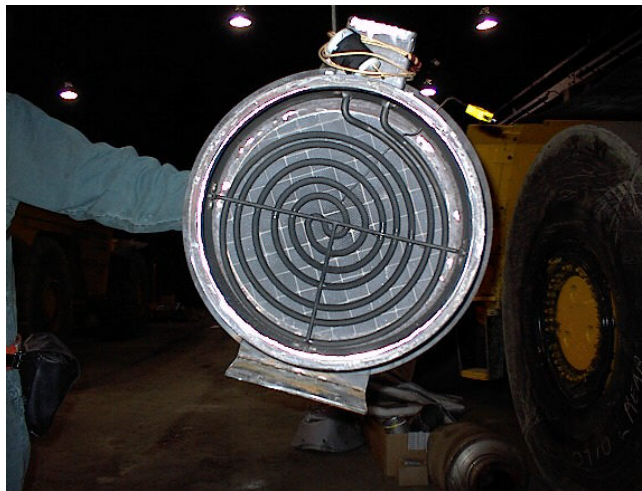
Figure 12 - DCL Bluesky DPF Silicon Carbide Monolith and Heater Element

A DPF system proposed by DCL International was chosen and adopted for retrofit on the other LHD vehicle included in the research. The system was chosen as a test of a promising active DPF technology that could reasonably fit within the constraints of Brunswick Mine operation requirements. This DPF system was designed around a single silicon carbide filter monolith. The monolith was wash coated with a platinum catalyst. An active electric heating system was added to the system to ensure DPF regeneration. This system had a 600-volt electrical element as shown in Figure 12 mounted in the inlet cone of the DPF housing. A regeneration station with the electrical power supply, switches, and controls and compressed air connections was designed as a separate unit external to the vehicle. The system was designed to be electrically regenerated at the end of each shift. The regeneration station was located in the garage on 3250 level. The plan was to have the operator(s) bring the vehicle to the garage at the end of each shift where the DPF system would be connected to the regeneration station. The two and a half hour window between work shifts was found to be sufficient to complete the regeneration cycle. The DCL system is referred hereinafter under the product name Bluesky.

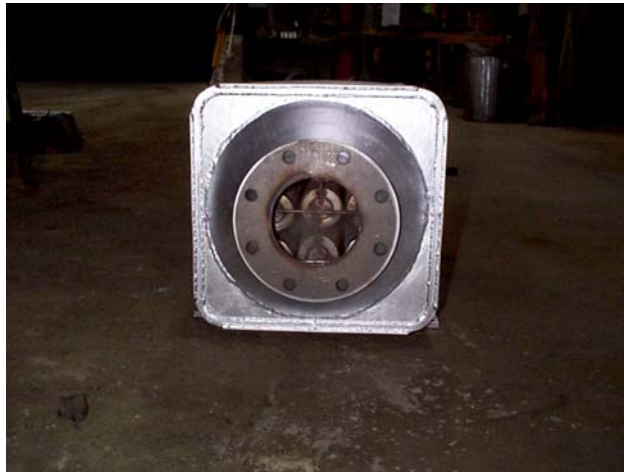
Figure 13 - Oberland Mangold DPF Glass Fiber Cartridges

A system proposed by Oberland Mangold of Germany was selected for application on the second MT436-B truck. The system used a glass fiber filter technology instead of wall flow monoliths of the other tested systems. The glass fiber cartridges had been approved by VERT following European tests [Mayer A, 1998]. The system also included a fuel-borne catalyst in the design to meet the regeneration requirements of lower exhaust temperatures in typical truck duty cycles. Oberland Mangold agreed that the Octimax 4804 additive would be appropriate for this use. The Oberland Mangold DPF system is shown below in Figure 13.

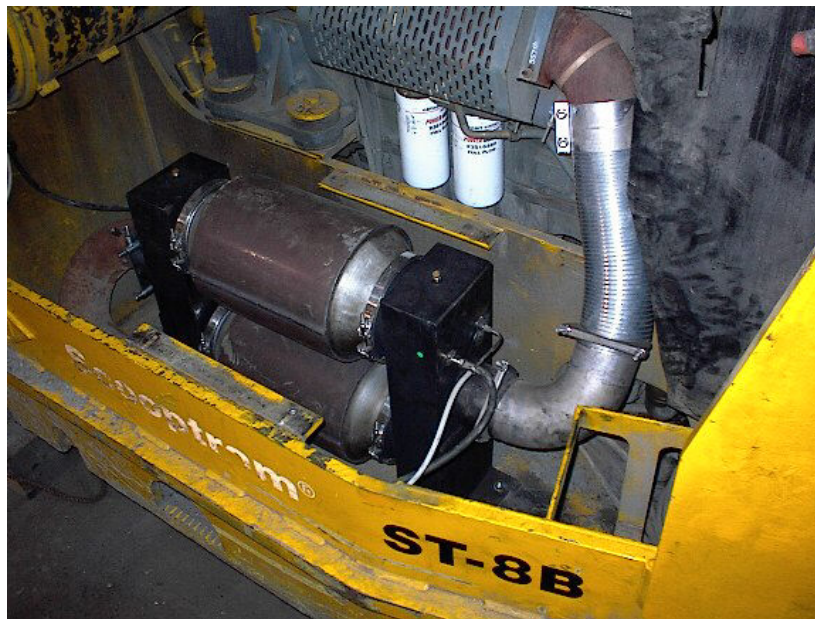
Figure 14 - ECS CatTrap Installation

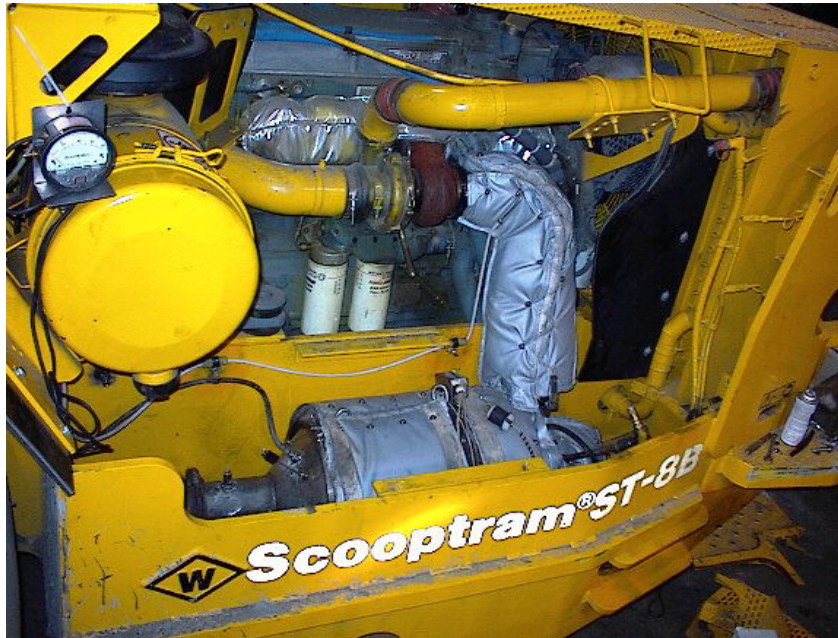
Figure 15 - DCL Bluesky Installation on VL247

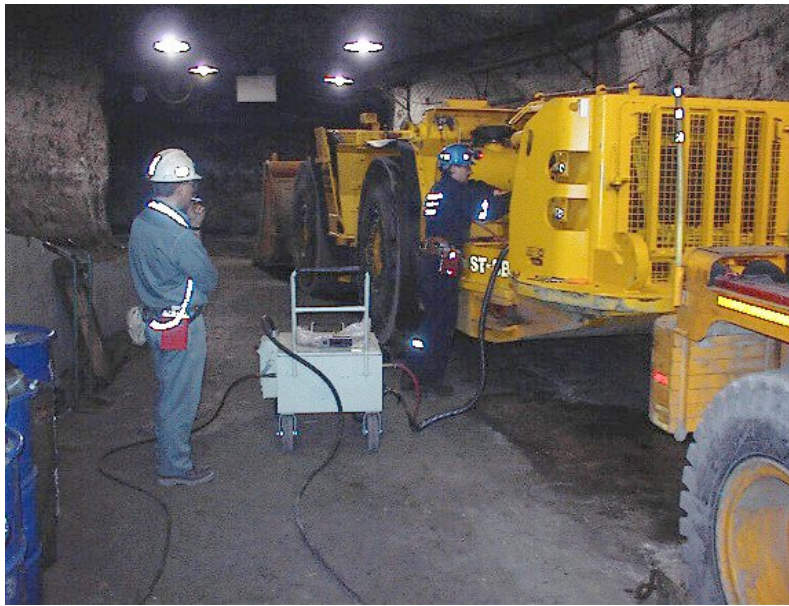
Figure 16 - DCL Regeneration Plug In Unit

The original plan was to regenerate DPF system in the shop at the end of each shift. The regeneration cycle, which was fully automated, would take 90 minutes from start to finish. Unfortunately, getting the electrical regeneration system connected and working properly presented a significant challenge. Within the first 8 hours of operation, the heating element that was designed to preheat the air entering the system failed. The investigation revealed that the element was inadequately designed. The preheat element was removed from the system leaving only the primary heat coil. This resulted in extending the regeneration cycle from 90 minutes to 120 minutes. At the same time two thermocouple connections were eliminated for simplicity and robustness. The elimination of these connections left only the 600v heating element connection and the compressed air connection. These modifications greatly simplified the connection procedure.

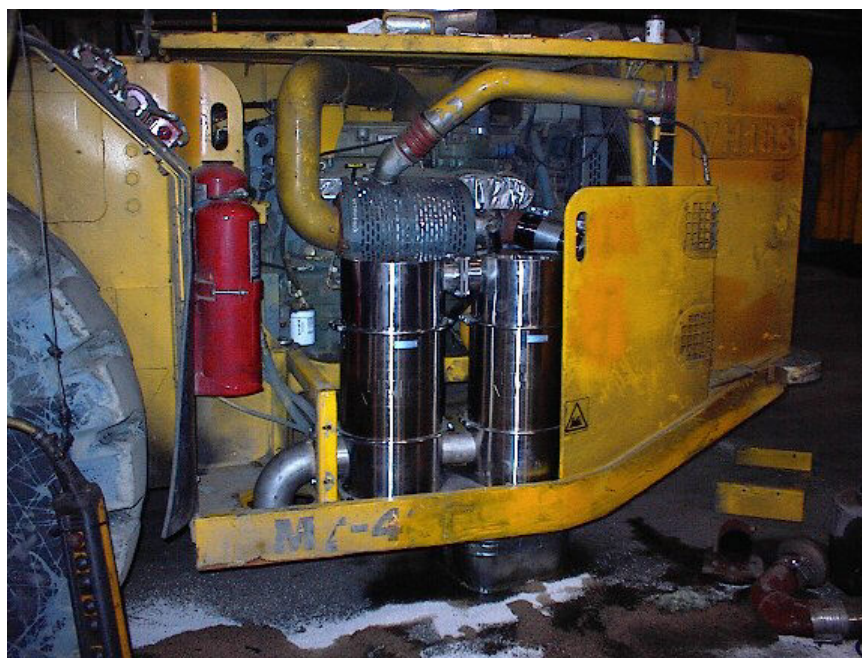
Figure 17 - ECS Octel Installation on VH183

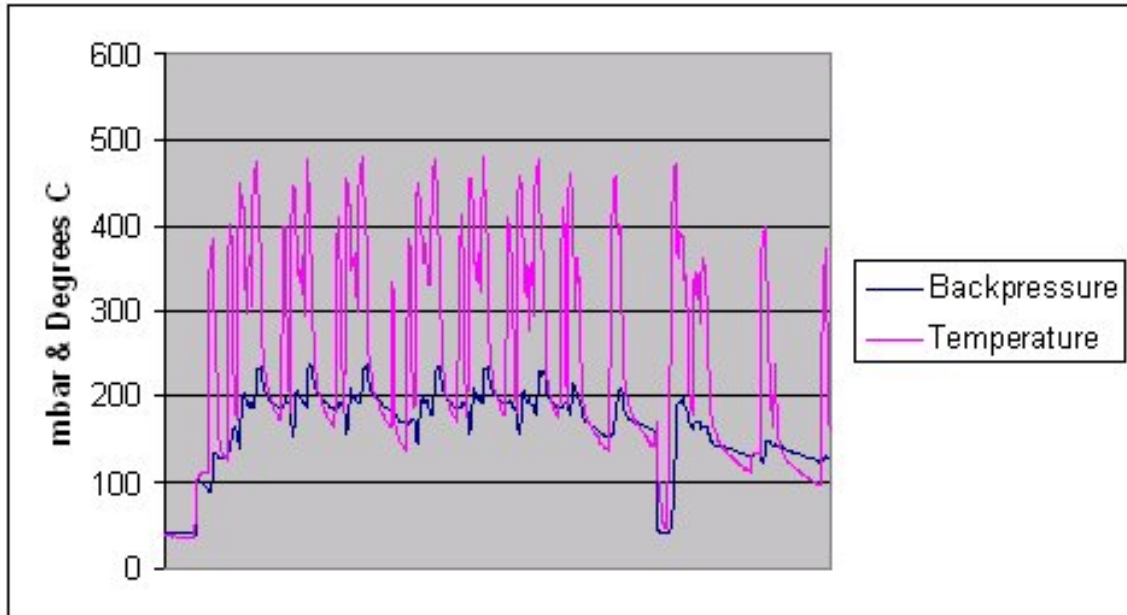
Figure 18 - Exhaust Temperature and Backpressure Traces for First Oberland Mangold DPF

The original DPF system accumulated 300 operating hours before removal and replacement with the larger volume unit. Figure 18 shows exhaust temperature (red line) and backpressure (blue line) traces for the first four days of operation. The exhaust backpressure was exceeding 200 mbar(80 in. wc) or twice the engine manufacturers limit of 100 mbar (40 in. wc)in the first days of operation.

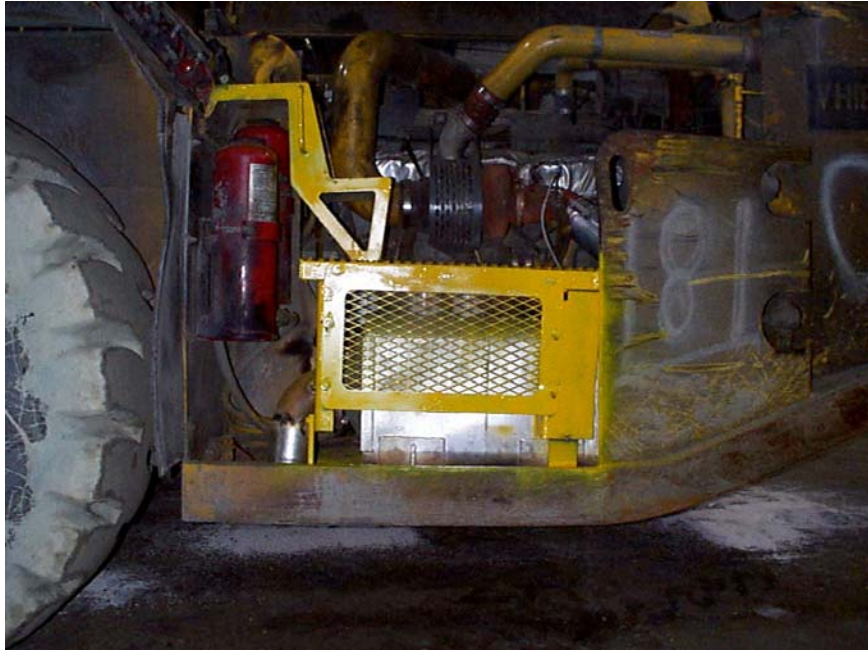
Figure 19 - Original Oberland Mangold DPF Installation

High exhaust backpressure problems eventually forced the decision to replace the original Oberland Mangold system with a larger volume unit. A new system was delivered to the mine and installed within two months Figures 19 and 20 show the two Oberland Mangold systems.

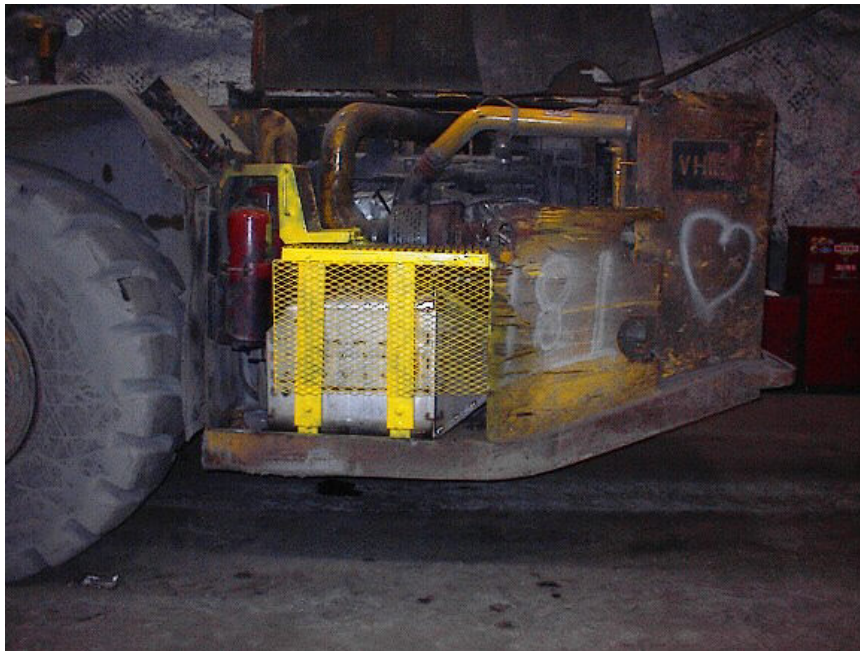
Figure 20 - Final Oberland Mangold DPF Installation

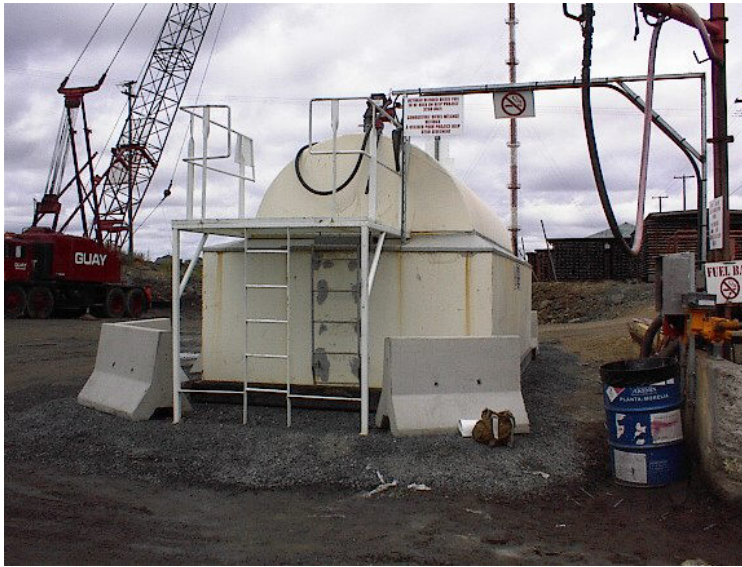
Figure 21 - Blended Fuel Storage on Surface

The bulk blending of fuel required an elaborate infrastructure for mixing, storing, and distributing blended fuel. It was important to limit use of blended fuel to the vehicles equipped with DPF systems. This was due to potential health risks associated with emissions of metallic compounds. A discreet bulk fuel supply was required with redundant fail-safe mechanisms to ensure that the two DPF equipped haulage trucks were the only vehicles capable of filling with the blended fuel. A six-thousand gallon bulk storage tank was installed on surface where the Octimax 4804 was added to the fuel at concentration of 400 ppm. Blending was done manually. The recommended volume of additive was hand poured into the tank during refilling process. The volume of fuel added to the tank was measured using a fuel meter. This process was sufficient to secure homogeneous mix of the two. Once homogenized, the blend remained in that state thanks to the stabilizing agent from the Octimax additive. A set of portable cube reservoirs were designated for transport and store blended fuel. Those reservoirs were equipped with a discreet fill/evacuation system. The cubes were moved underground to the "1000 level" fuel bay by vehicle transport and shaft access. A second bulk fuel tank of three thousand gallon capacity was installed at the fuel bay on "1000 level". Blended fuel from the cubes was transferred to this tank. A separate fill pump and nozzle system was installed at 1000 fuel bay. The system had a Wiggins quick disconnect fuel nozzle connection. The matching female quick connect fittings were installed on the two DPF equipped trucks.

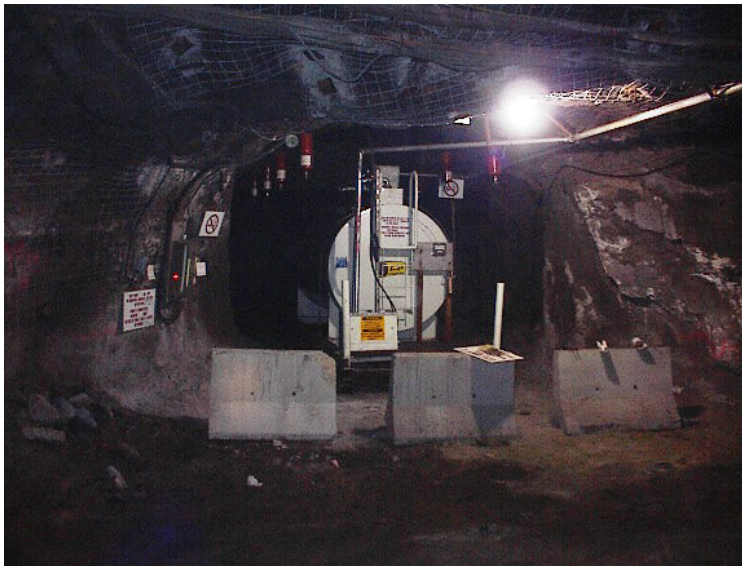
Figure 22 - Blended Fuel Storage at 1000 Level

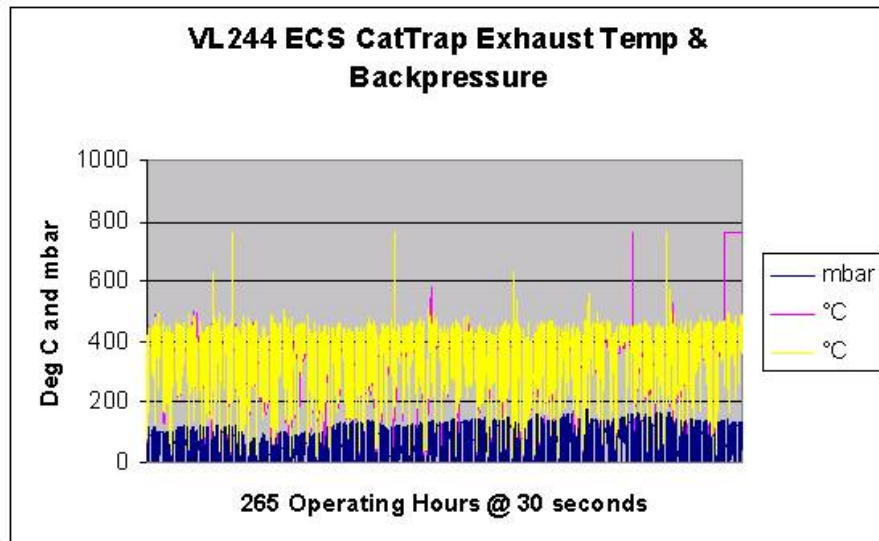
Figure 23 - ECS CatTrap Exhaust Temperature and Backpressure

The typical exhaust temperature and backpressure trace for LHD VL244 is shown in Figure 23. Temperature peaked between 375° and 400°C. The system manufacturer expected that the filter would be successfully regenerating at those temperatures for 30% or more of the total duty cycle. Backpressure reached a plateau of around 120 mbar or 50 inches of water. The backpressure values measured by mechanics at monthly PM inspections were consistent with those measured by the loggers.

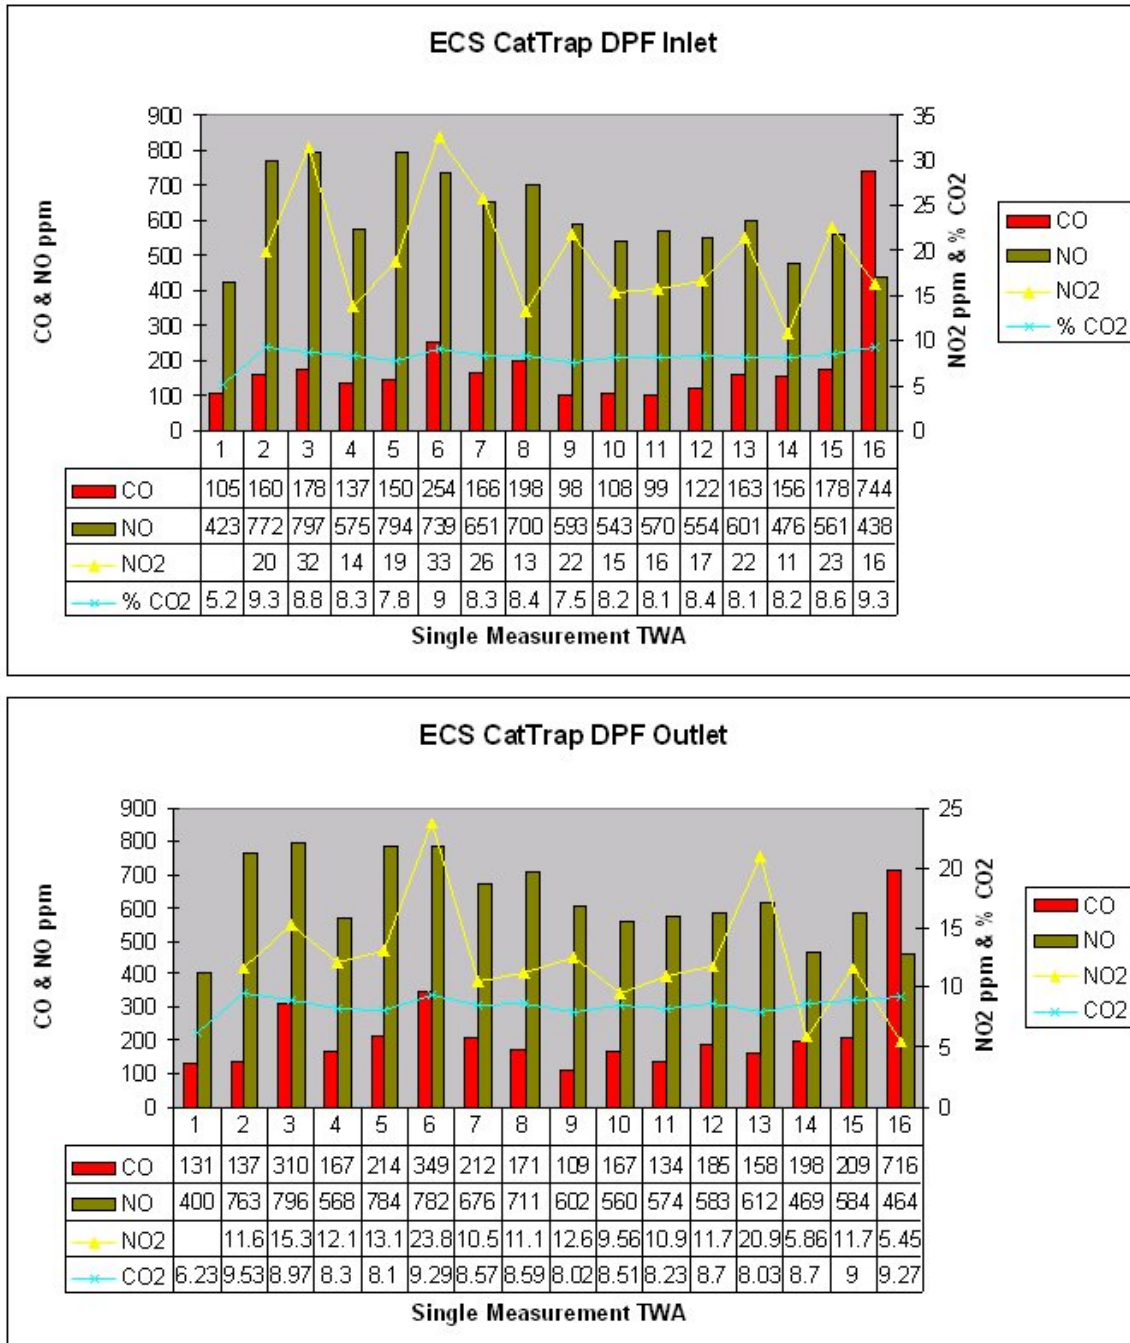
Figure 24 – Gaseous Emissions For VL244 With ECS CatTrap

Over the course of the project a total of 16 emissions tests were performed using UGAS at both the inlet and outlet of the DPF. The results are shown in Figure 24. The results showed that nitrogen dioxide emissions were not substantially affected by the base metal catalyst. Carbon monoxide emissions were consistent and correlating well to small fluctuations in carbon dioxide. All measured CO₂ emissions were near 8 to 9% indicating good tests at full engine stall condition.

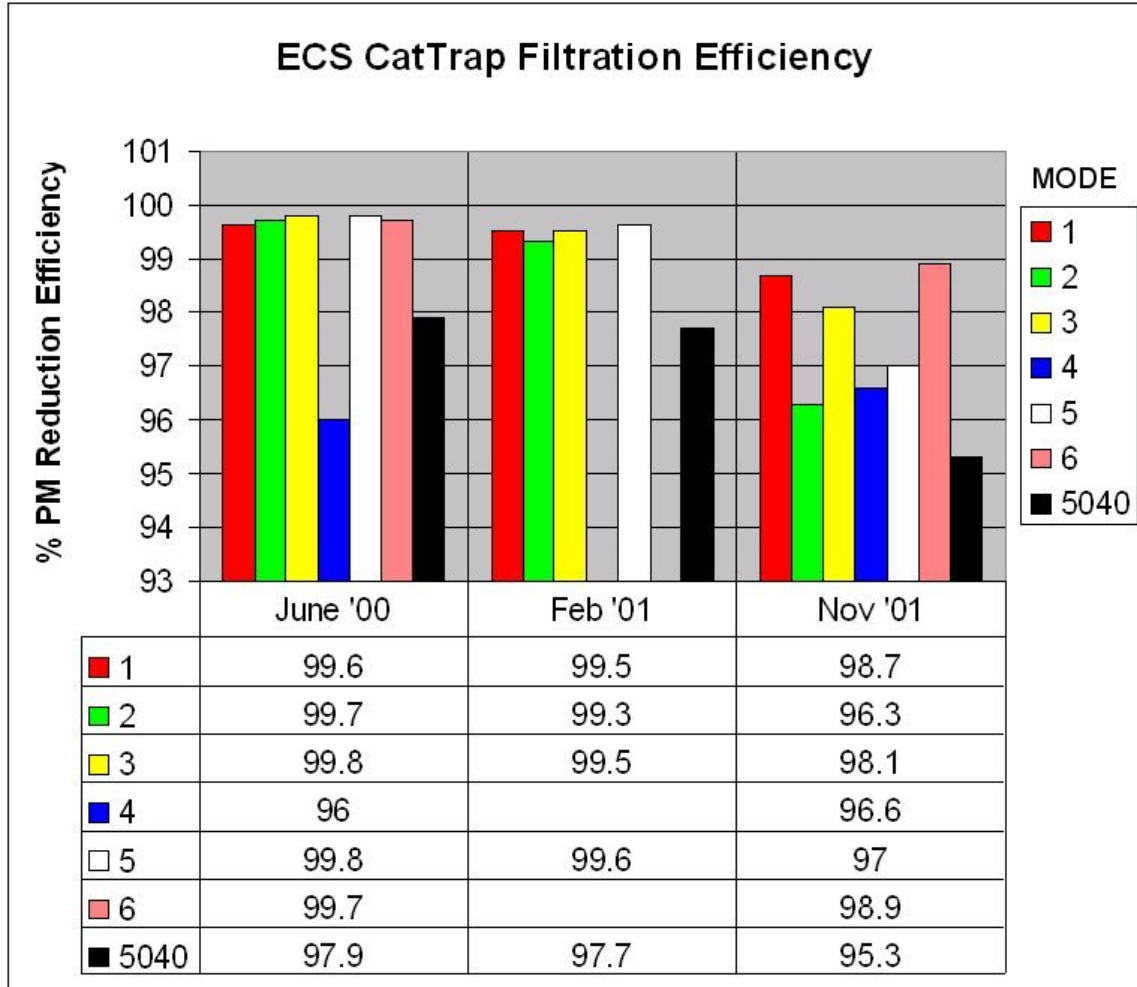
Figure 25 – DPM Filtration Efficiencies For ECS CatTrap DPF System

The carbon content test results obtained using 5040 method were found to correlate well to the results obtained using the six-mode testing and the NanoMet instrument.

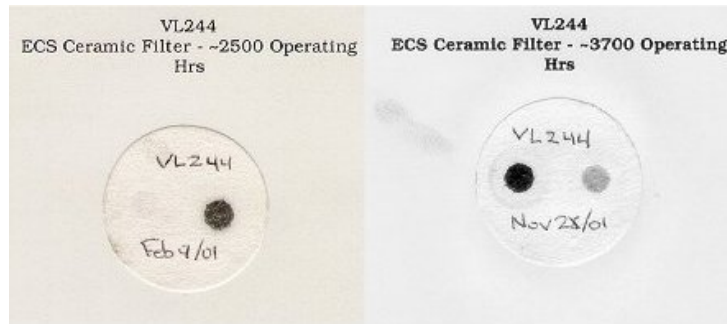
Figure 26 – Bacharach Smoke Index Measured for ECS CatTrap DPF System

The Figure 26 shows the filter sample taken by mechanics with the UGAS using Bacharach smoke index (BSI) option.. The black dot represents the DPM sample collected from the inlet side of the filter and the light gray dot represents the sample collected at the outlet side of the filter. The samples collected at the final tests in November 2001 indicate the reduced efficiencies observed with other methods (see Figure 25).

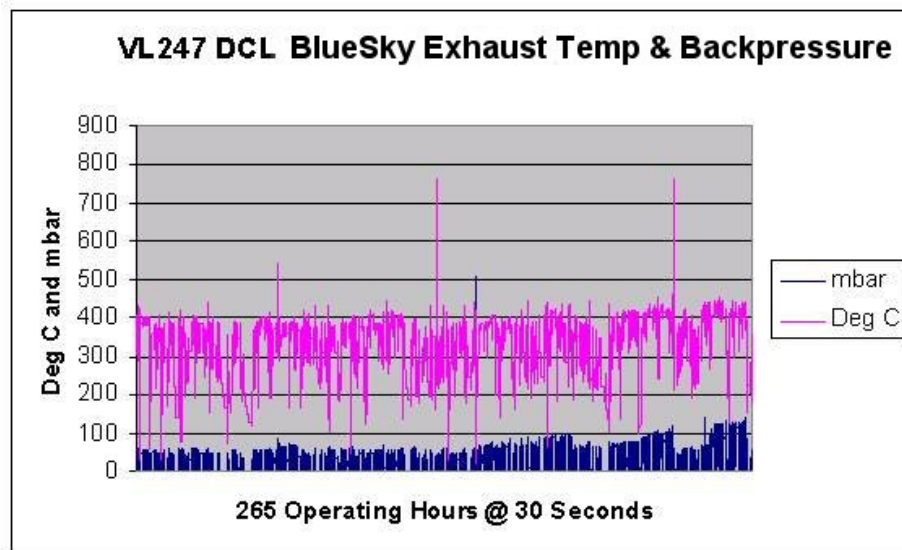
Figure 27 - Exhaust temperatures and engine backpressures recorded for LHD VH247 equipped with DCL Bluesky DPF system

The Nothiger datalogger and sensor system used on VL247 to establish time traces of exhaust temperature and backpressure was prone to technical problems throughout the study. The RTD temperature sensors used at the DPF inlet side were particularly prone to failures due to their proximity to the electrical regeneration unit that generated the additional heat. Figure 27 shows temporal distribution of exhaust temperature and engine backpressure. This data is fairly consistent with corresponding data obtained for the LHD VL244. Exhaust temperatures at peak engine load were between 350° and 400° C, These temperatures were theoretically within the range of temperatures needed for passive regeneration of this system. Backpressures observed with this system were slightly lower than those observed for the ECS system on LHD VL244. The backpressure reached a plateau at approximately 100 mbar or 40 inches of water. This indicates that regeneration was occurring frequently enough during the duty cycle to sustain continuous operation of the system. This was verified by the additional measurements of engine backpressure done by mechanics during monthly PM inspections.

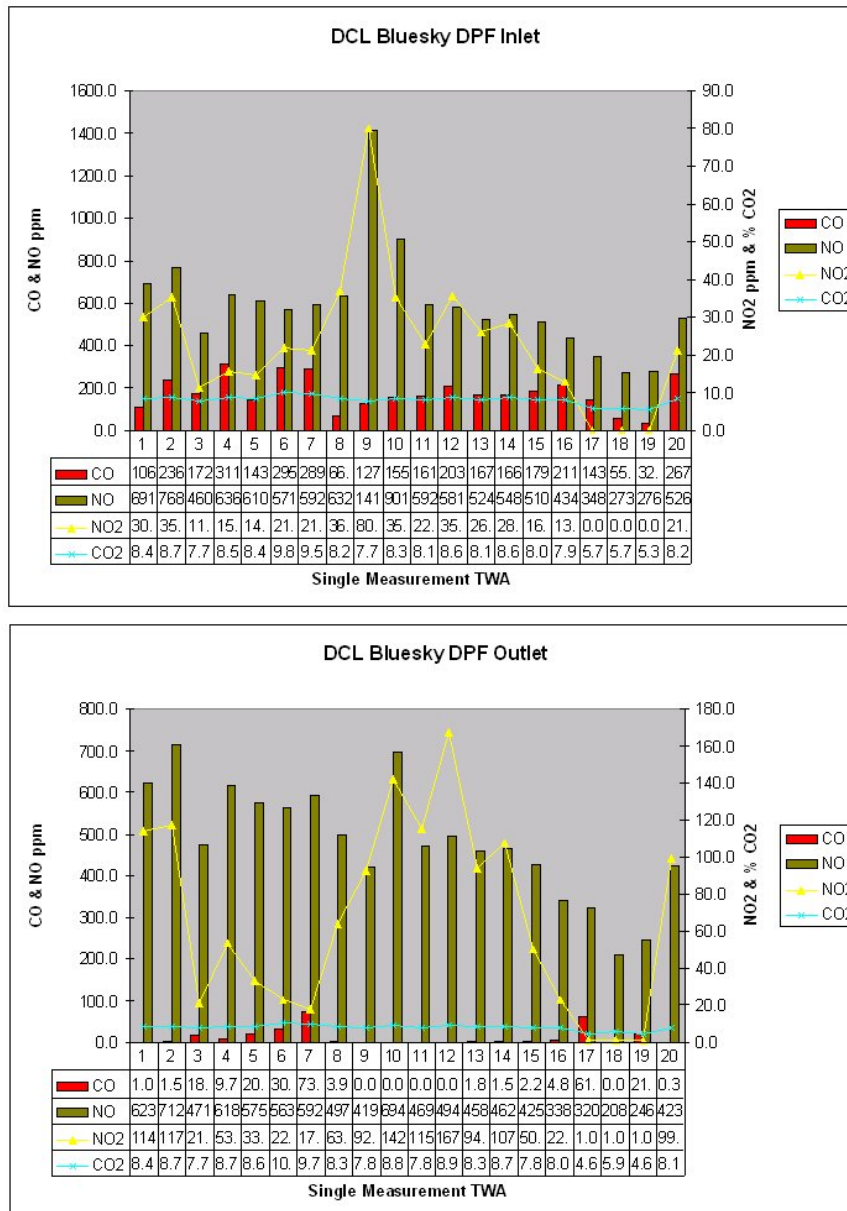
Figure 28 - Gaseous Emissions For VL247 With DCL Bluesky DPF System

Results of the emissions measurements conducted during 20 tests are shown in Figure 28. The measurements were conducted at the inlet and outlet sides of the DPF using the UGAS system. The CO was converted almost completely across the platinum catalyzed filter (see Figure 28). In some cases measurements showed that the concentrations of NO₂ at the outlet of the DPF were four fold higher than corresponding concentrations on the inlet side of the DPF. These results emphasized the importance of including gaseous emissions measurements in tests designed for evaluation of the effects of DPF systems on the particulate matter emissions.

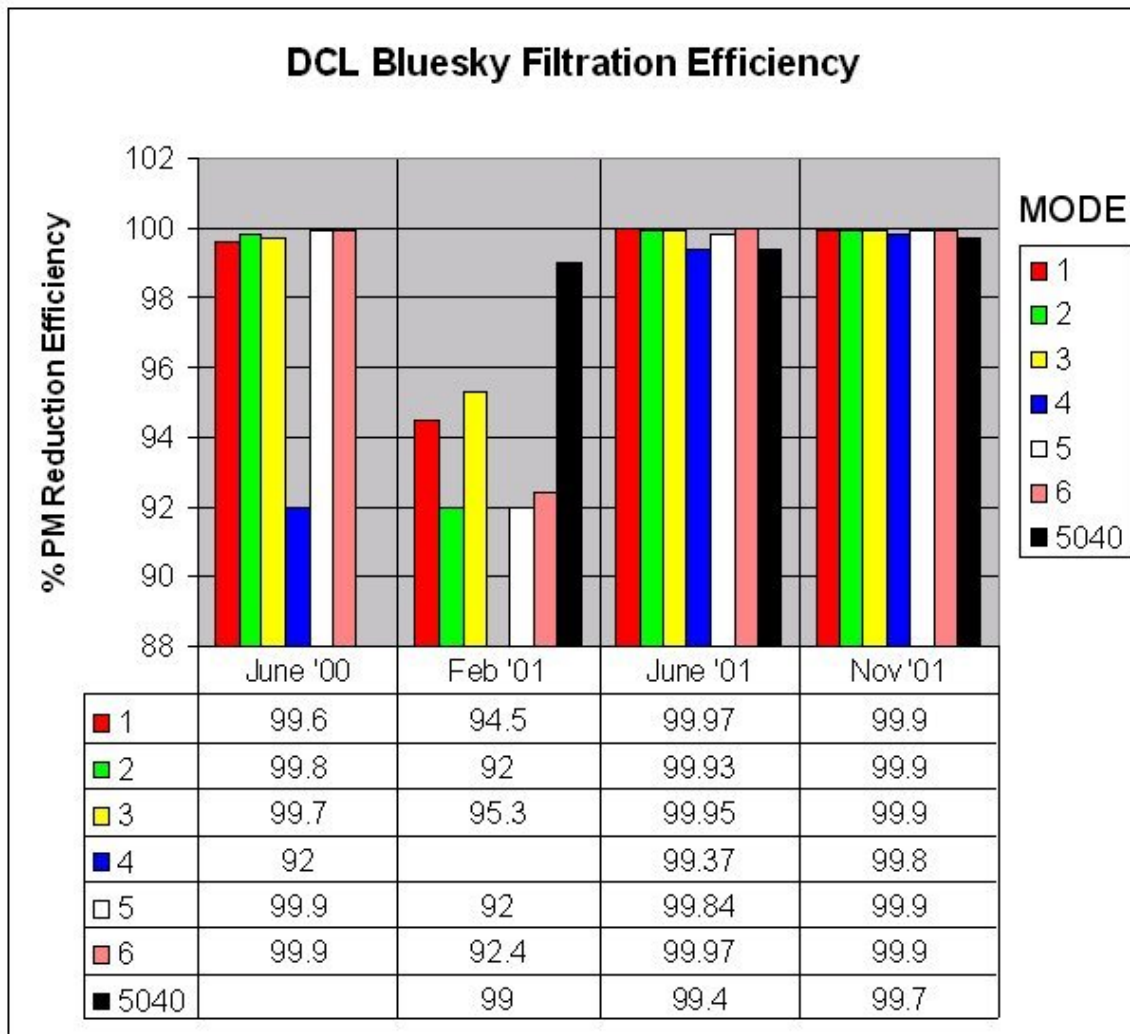
Figure 29 - DPM Filtration Efficiencies For DCL Bluesky DPF System

The results of particulate matter emissions measurements conducted during four detailed performance evaluations are shown in Figure 29. In terms of filtration efficiency, this system was the best performer of all systems tested in the project. The results were consistently indicating filtration efficiencies in excess of 99 percent. The results obtained with NanoMet during tests conducted in February of 2001 were found to be inconsistent due to instrumentation problems but are presented nonetheless. It is important to note that these tests were conducted during the isolated zone study in a drift at ambient air temperature just above the freezing point. We believe that the NIOSH 5040 method provided accurate results.

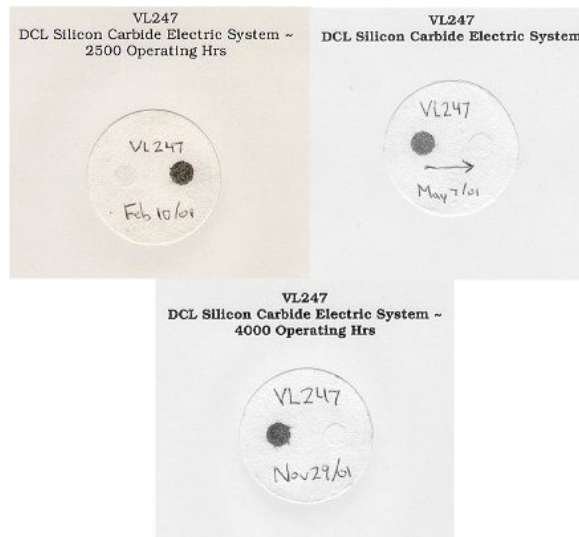
Figure 30 – Bacharach Smoke Density Results on VL247 with DCL Bluseky DPF System

Figure 30 shows the filter sample taken by mechanics with the UGAS using the BSI option on the Ecom analyzer. The black dots represent the DPM sample collected from the exhaust at the inlet side of the filter (an 8 on the 0-9 index scale) and the light gray dot represents the DPM sample collected at the outlet from the filter (a 1 on the 0-9 index). The results of smoke density tests confirmed the results obtained using other more sophisticated methods.
