FINAL REPORT OF INVESTIGATION
TO THE DIESEL EMISSIONS EVALUATION PROGRAM
(DEEP)

NORANDA INC. - BRUNSWICK MINE
DIESEL PARTICULATE FILTER
(DPF)
FIELD STUDY

OCTOBER 2004

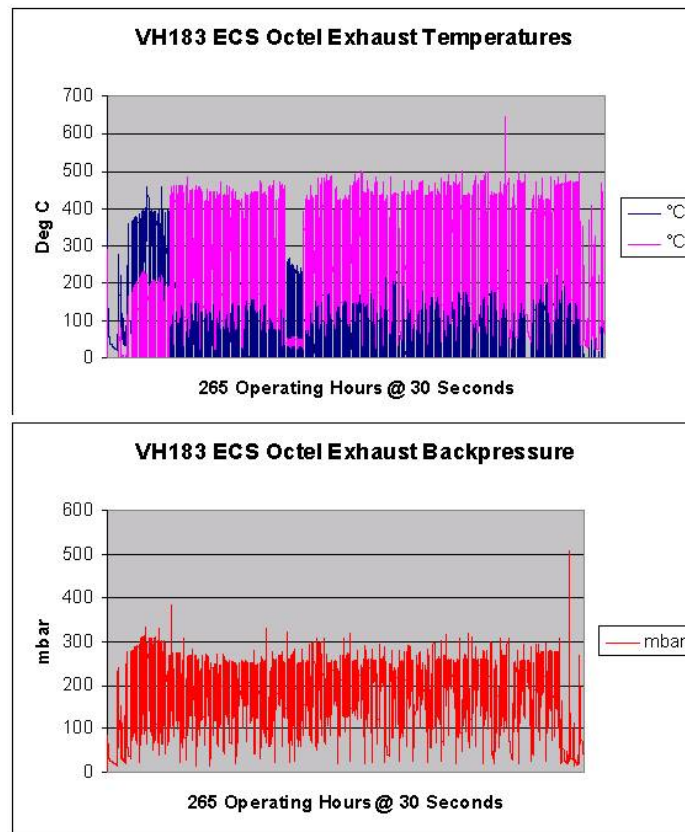
Figure 31 - ECS Octel Exhaust Temperature and Backpressure

lower DPF regeneration temperatures to approximately 300° C. Therefore, regeneration should have occurred more frequently than it was observed.. Figure 31 also shows that the backpressures were for a substantial time above 200 mbar and reaching periodically even 300 mbar. This high backpressure indicates that the regeneration process was slow and insufficient. The Octel representative offered the hypothesis that regeneration did not occur over the duty cycle since the moisture content of the soot buildup inside the filter monolith was less than expected. Low organic carbon content was hypothesized to be the result of efficient combustion inside the electronically controlled engine and operating conditions. These factors in combination with excessive engine idle times contributed to the insufficient DPF regeneration.

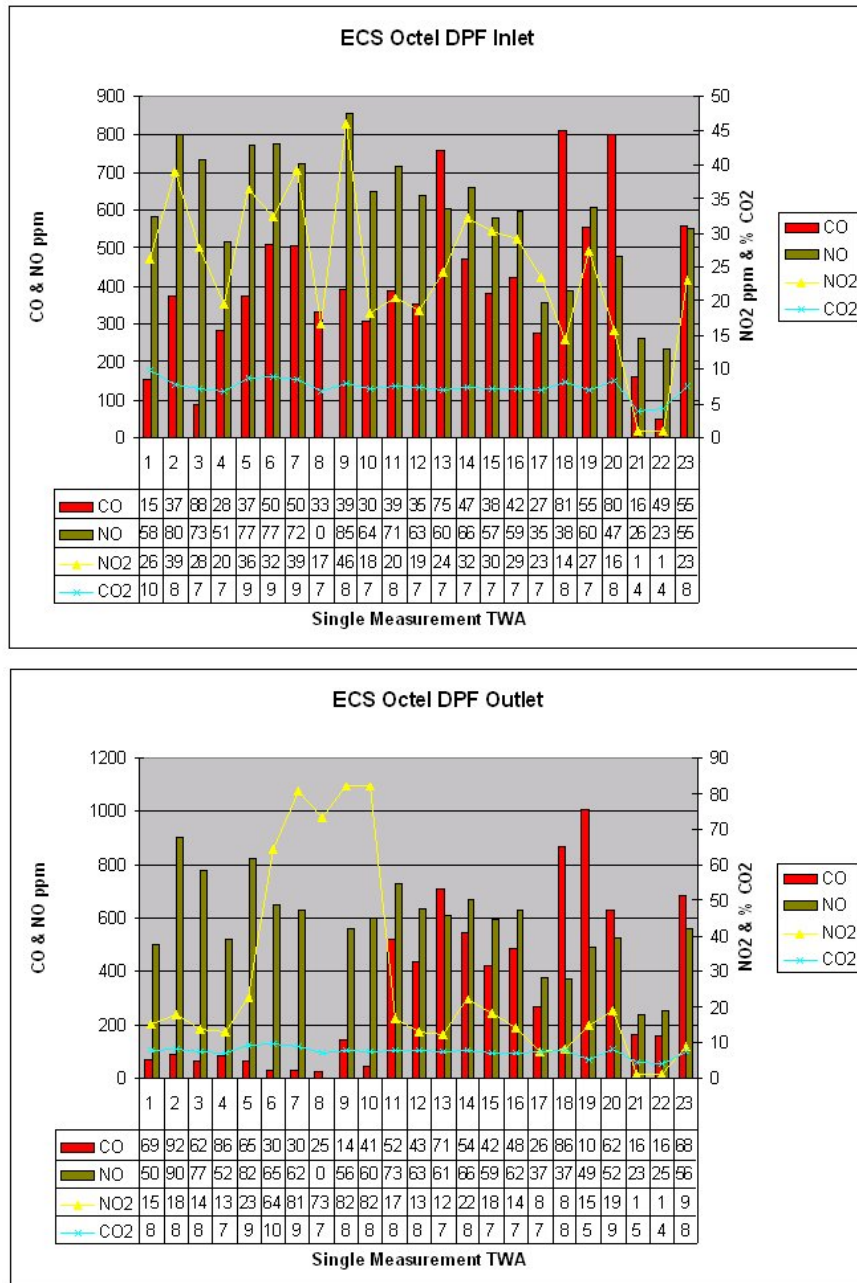
Figure 32 - Gaseous Emissions For VH183 ECS Octel DPF System

while the diesel oxidation catalyst was in place showed the CO conversion and reduction (see Figure 32). Once the diesel oxidation catalyst was removed, CO emissions at the outlet were often higher than those at the inlet due to combustion of DPM inside the filter while the engine was under full stall testing conditions. Measurable conversion of nitrogen oxide to nitrogen dioxide was taking place in the system while the oxidation catalyst was in place, but when the catalyst was removed conversion was not measurable.

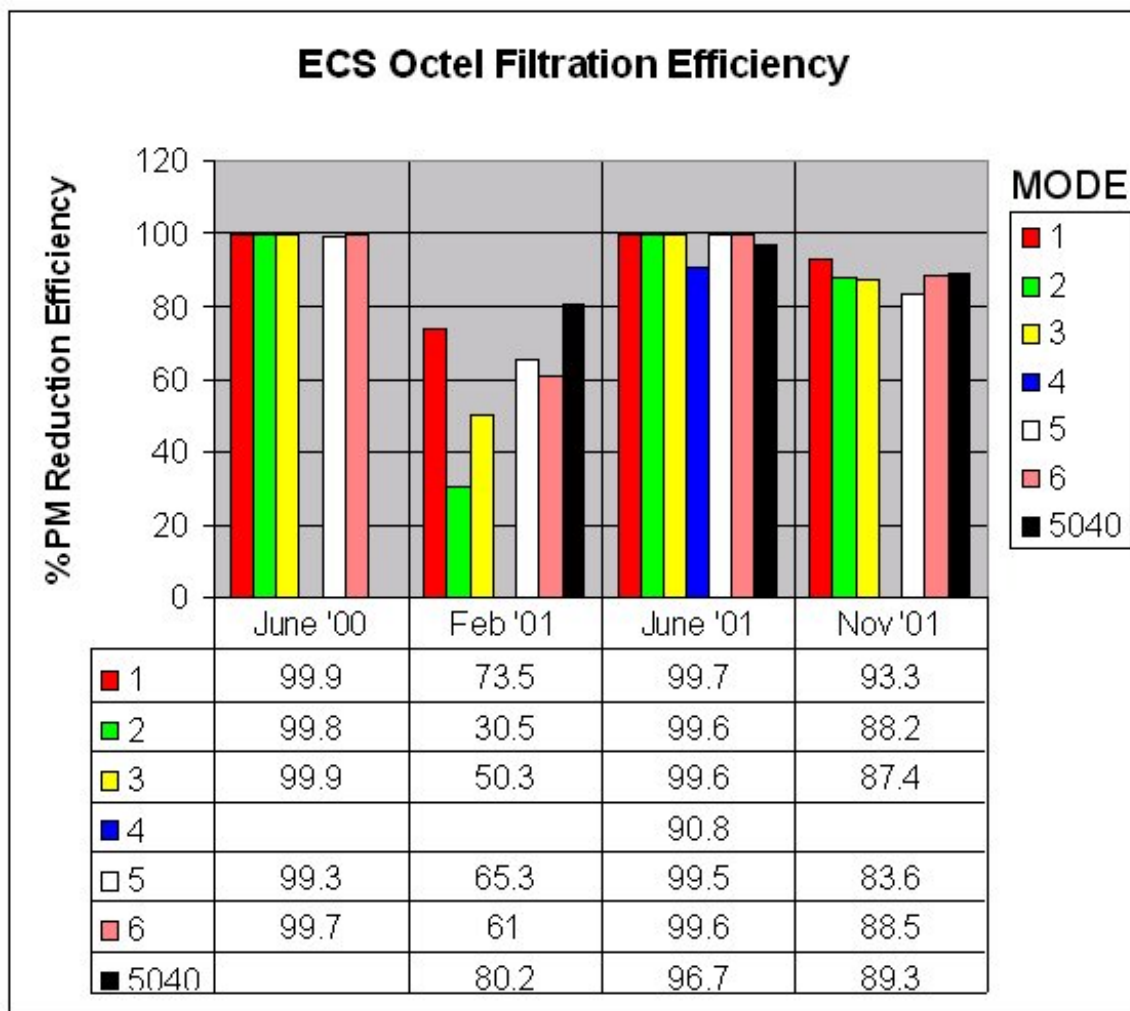
Figure 33 – DPM Filtration Efficiencies for ECS Octel DPF System on VH183 Truck

The filtration efficiency test results, shown in Figure 33, illustrate the high efficiencies of the newly installed system. The tests in February 2001 show a severely failed filter and the final tests in November 2001 show a partially failed filter. The results of the 5040 method carbon content analysis on the samples collected during the last three sets of tests correlate very well with the filtration efficiency measured by the NanoMet instrument. Test results showed that the new filters had efficiencies of approximately 98%, similar to the other tested DPFs. The severely damaged filter system had efficiency as low as 30%, and the partially damaged system had efficiency as low as 82% depending on which test mode was used for analysis.

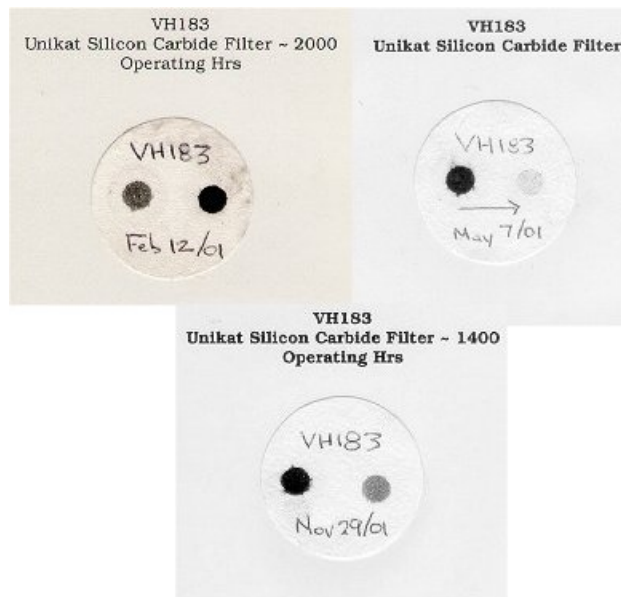
Figure 34 - Bacharach Smoke Density Results on VH183 with ECS Octel DPF System

The results of the Bacharach Smoke measurements are shown in Figure 34. The BSI measurements showed that DPF systems on VH183 failed in two instances. The first set of filters failed after 2000 operating systems hours and the second set of filters failed after 1400 operating hours. At other test instances when the DPF system was not compromised the efficiency was relatively high. These results are in direct correlation with results obtained using other more sophisticated methods. Therefore this method is suitable for quick and inexpensive verifications of DPF system performance.

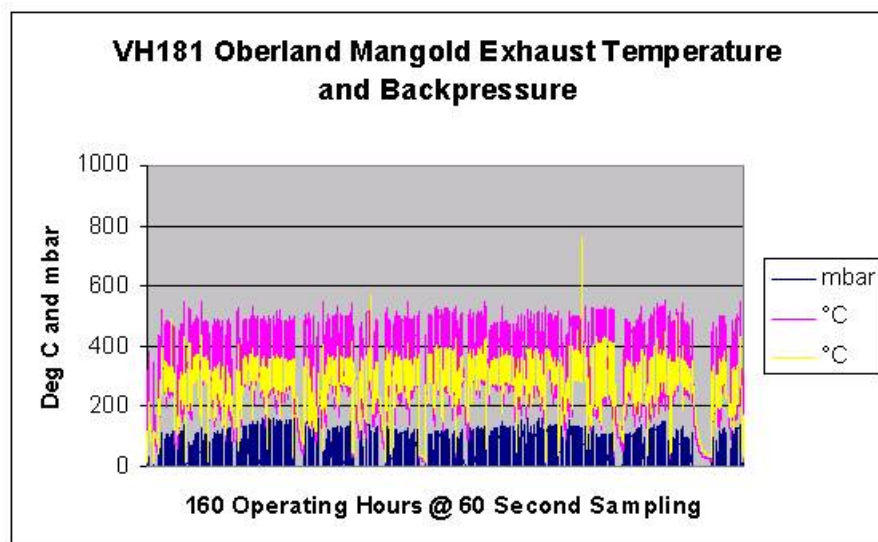
Figure 35 - Oberland Mangold Exhaust Temperature and Backpressure

The data that was retrieved from the datalogger was backed up by measurements of backpressure performed by mine mechanics at monthly intervals. The backpressure reached a plateau of approximately 120 mbar or 50 inches of water. The data presented in Figure 35 shows backpressure values increasing and decreasing in a regular pattern, which indicates at least partial regeneration occurring during the duty cycle. The exhaust temperature traces show temperatures at the inlet to the system well above 400° C. The temperature profile compares well to one for the other truck used in the project but the backpressures and apparent regeneration profiles are drastically different. The glass fiber filter media appear to have captured less particulate than silicon carbide monolith media used in the other system. The lower loading inside the filter media made it easier to regenerate when temperatures reached high enough levels to ignite the trapped soot.

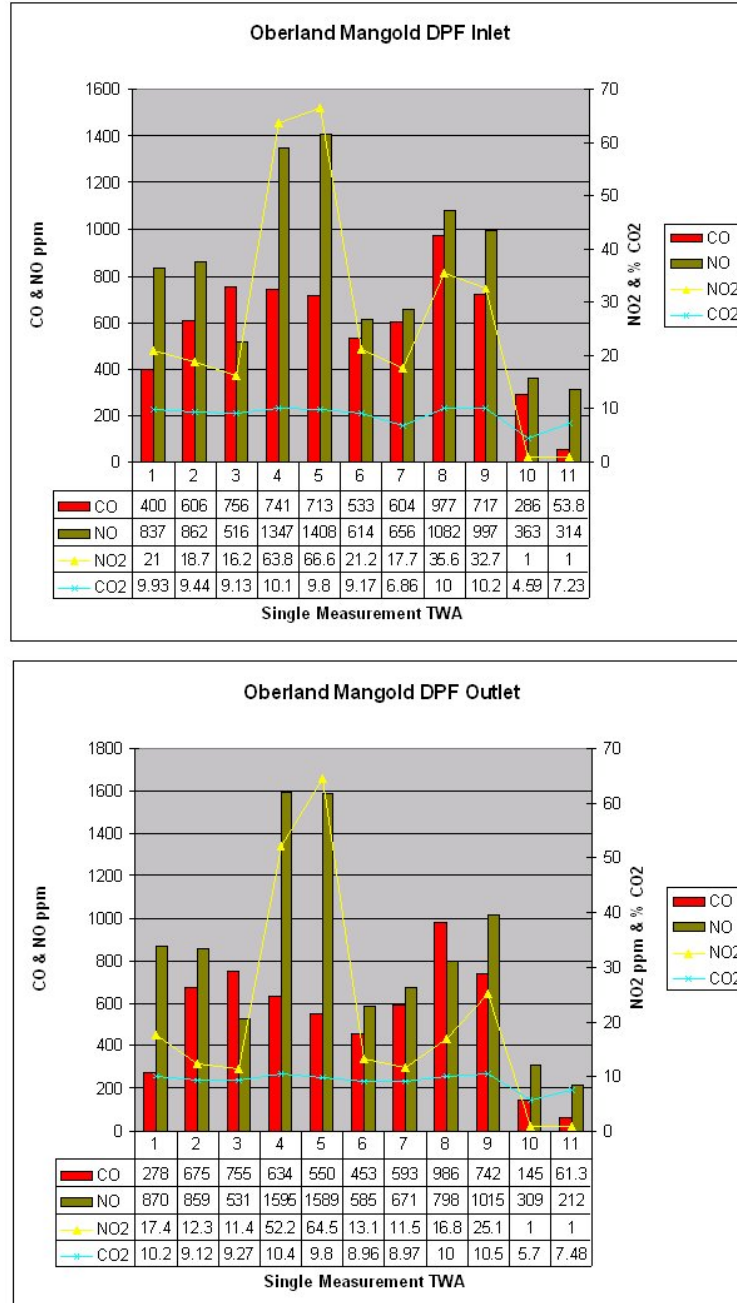
Figure 36 – Gaseous Emissions For VH181 With Oberland Mangold DPF

The results of gaseous emissions measurements made on VH181 truck equipped with the Oberland Mangold DPF system are shown in Figure 36. The non-catalyzed DPF with glass fiber media did not affect either carbon monoxide or nitrogen dioxide emissions. Carbon dioxide emissions and exhaust temperatures were consistent throughout the tests with the exception of the final test indicating that proper testing protocol was followed with full engine stall.

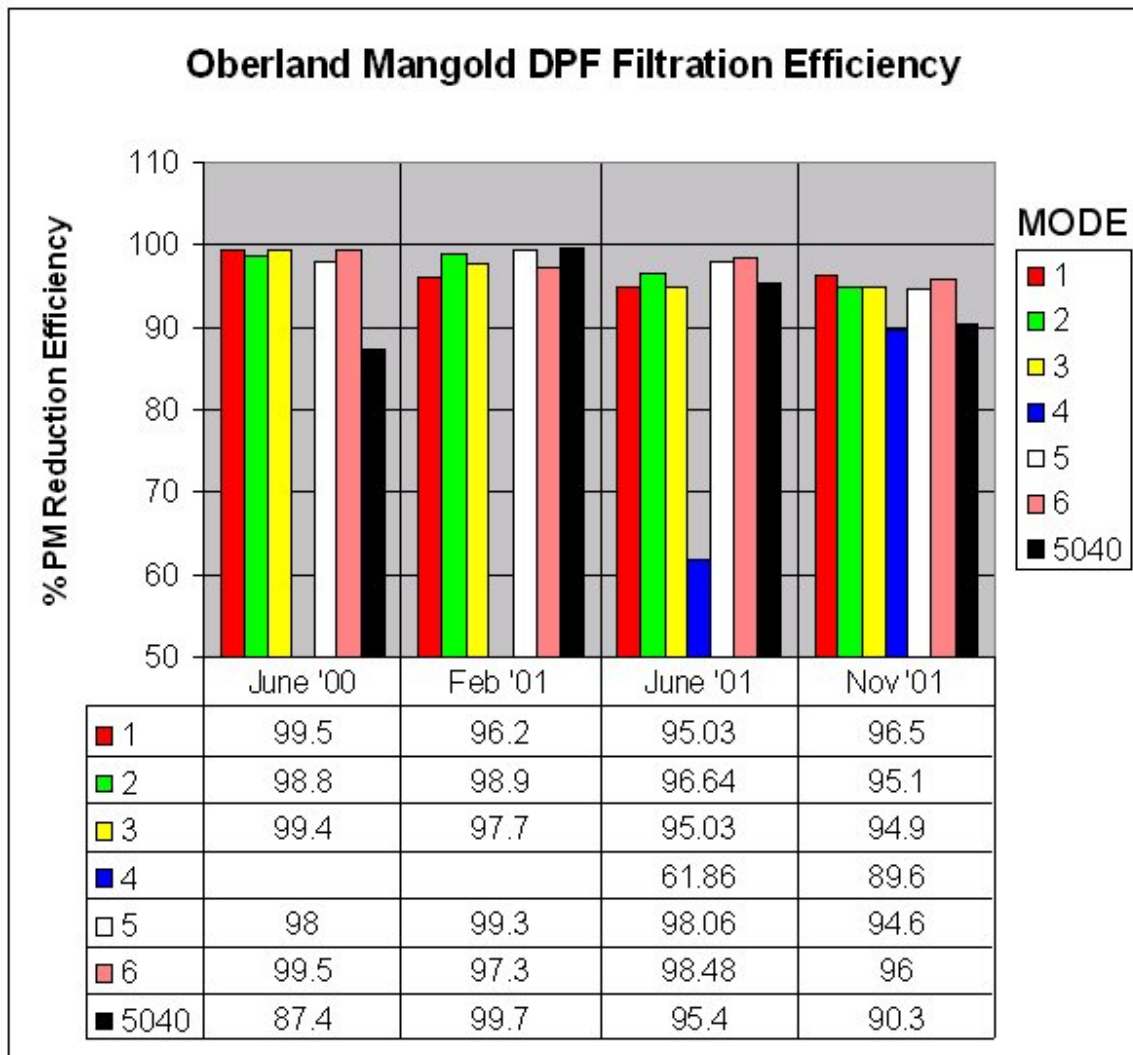
Figure 37 – DPM Filtration Efficiencies For Oberland Mangold DPF System on VH181 Truck

The results of particulate matter emissions measurements, shown in Figure 37, indicate that fiber knitted filter consistently exhibited lower filtration efficiency than the other three wall flow monolith DPF systems tested in this study. The first set of results was generated in June 2000 during the tests involving the original DPF with 25 filter cartridges. The other three tests were performed with the larger, 52 cartridge DPF system. The efficiency of the system was found to be lowest when particulate matter emissions obtained for tests at mode 4 (idle) were used for calculation. The PM emissions measurements obtained for remaining modes were providing consistent results and showed as low as 90% or slightly below. The NIOSH 5040 method analyses agreed very closely with NanoMet results in the 2nd and 3rd sets of tests but were 5 to 10% below NanoMet results in the 1st and 4th sets.

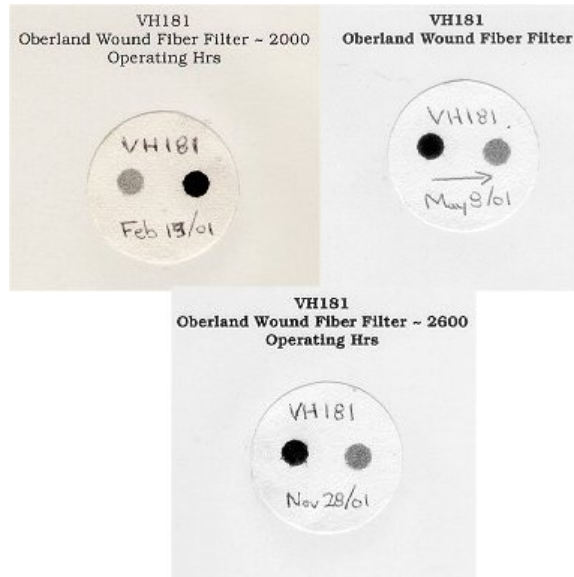
Figure 38 - Oberland Mangold Octel Bacharach Smoke Density Results

The results of Bacharach smoke index (BSI) tests shown in Figure 38 agree better with the NIOSH 5040 method results than with the NanoMet results. Whereas the BSIs observed for the other three tested DPF systems that are using wallflow monolith technologies were consistently between 0 or 1 at the outlet, the BSIs for Oberland Mangold System that utilize fiber cartridges were closer to 4 or 5 on 0 to 9 scale. Bacharach testing results were consistent throughout the project.

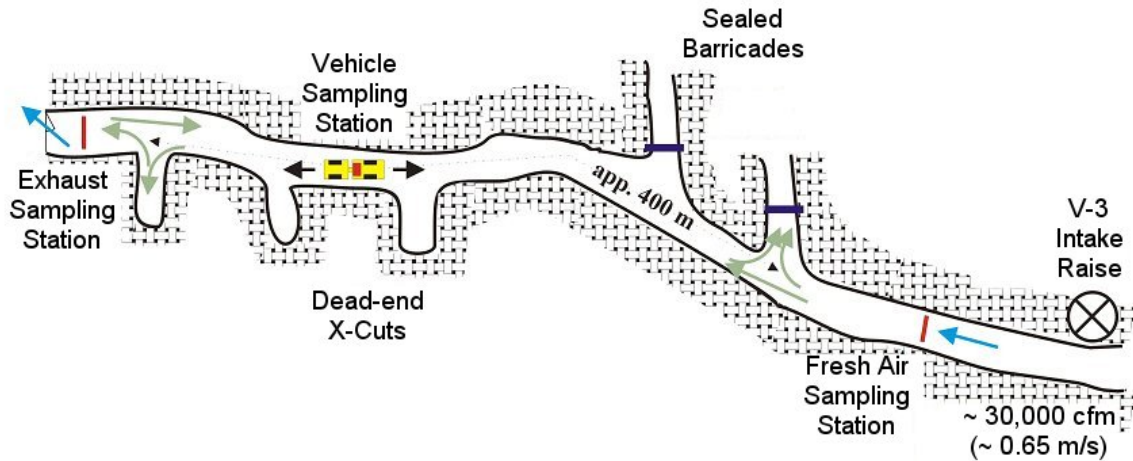
Figure 39 - 525-5 Sublevel Isolated Zone

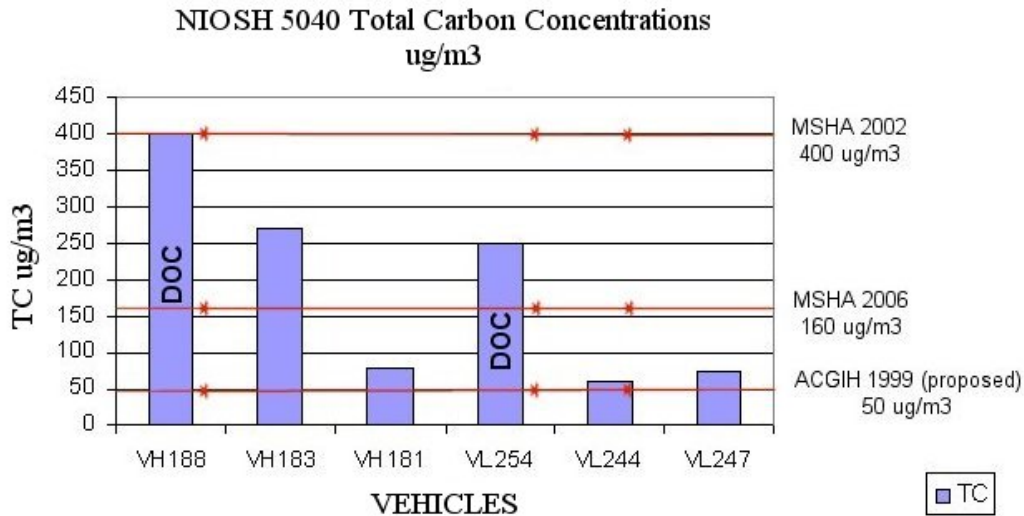
Figure 40 – Total Carbon Concentrations in Isolated Zone for Different Test Vehicles

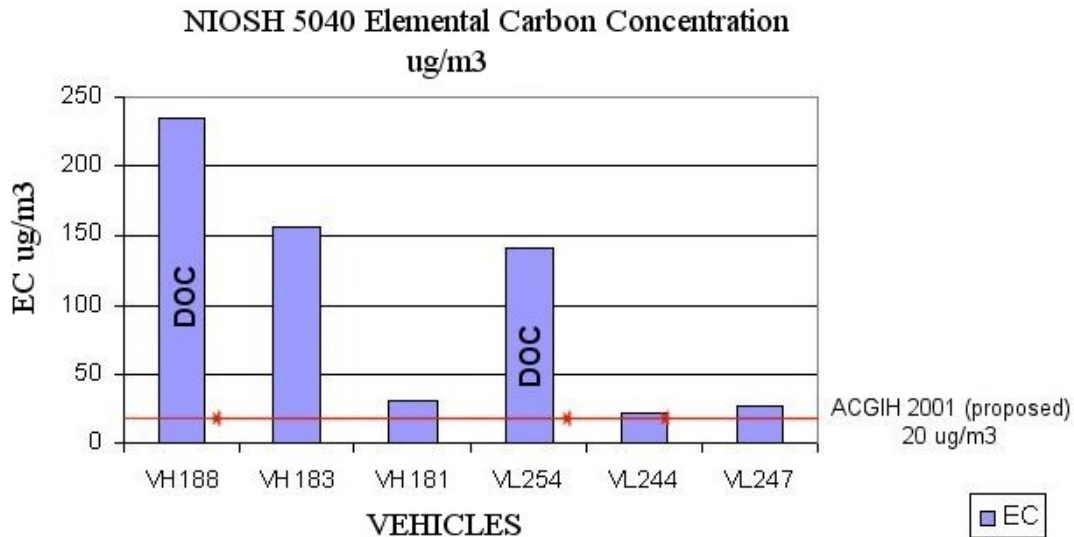
Figure 41 - Elemental Carbon Concentrations in Isolated Zone for Different Test Vehicles

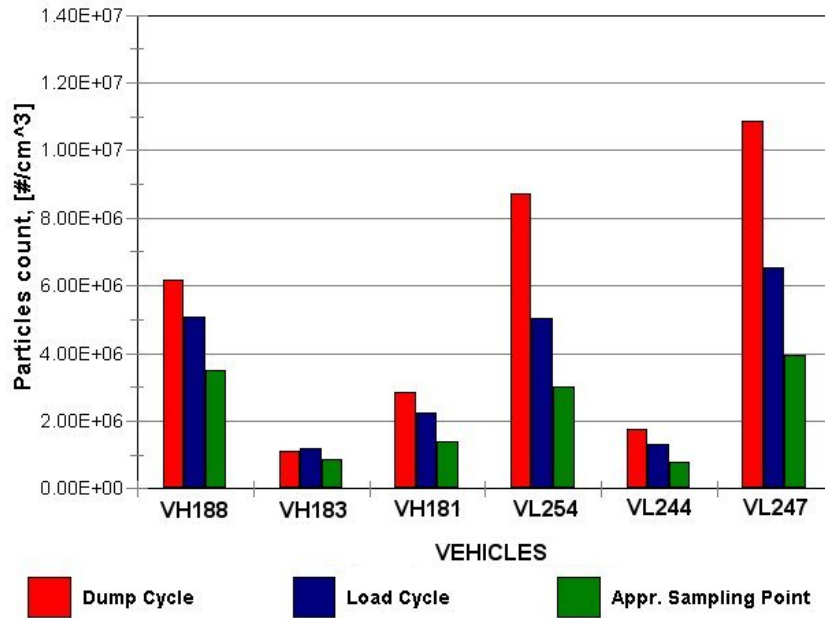
Figure 42 - Particle Concentrations by Number Measured in Isolated Zone for Different Test Vehicles

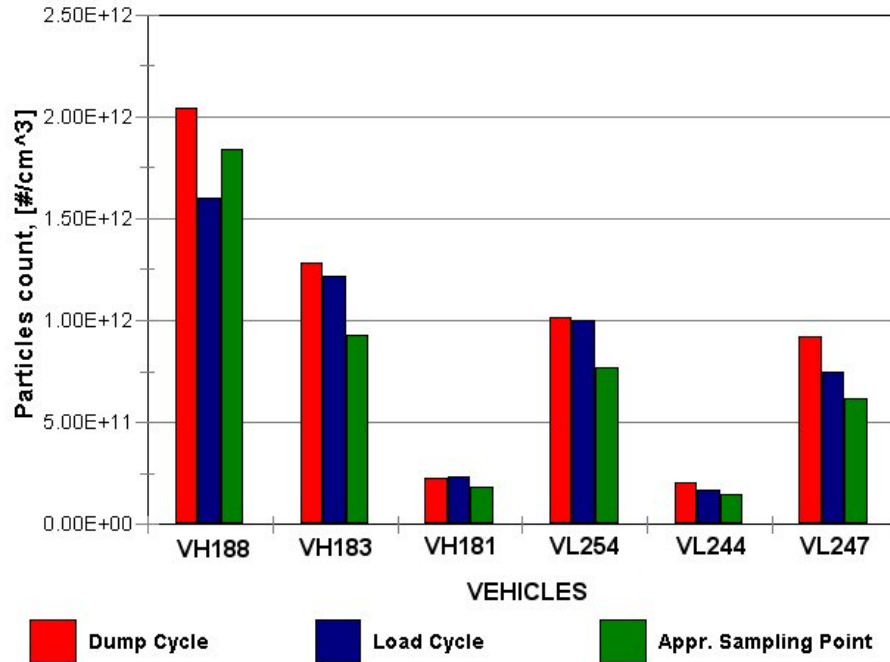
Figure 43 - Particle Concentrations by Volume Measured in Isolated Zone for Different Test Vehicles

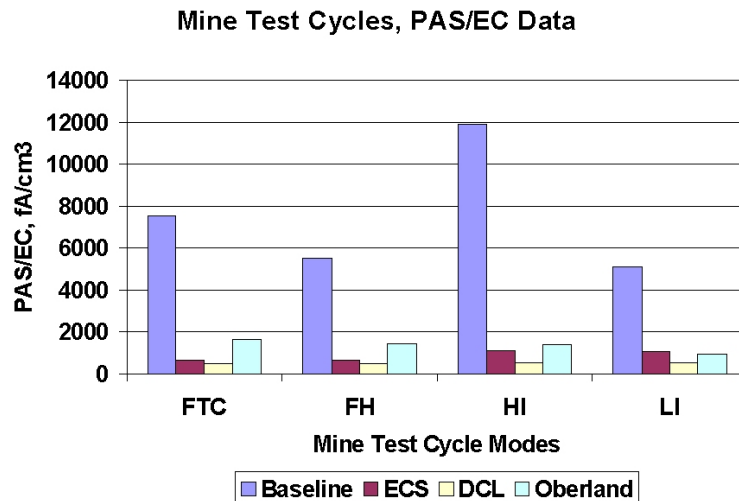
Figure 44 – Results of Measurement with PAS 2000, Mine Test Cycles

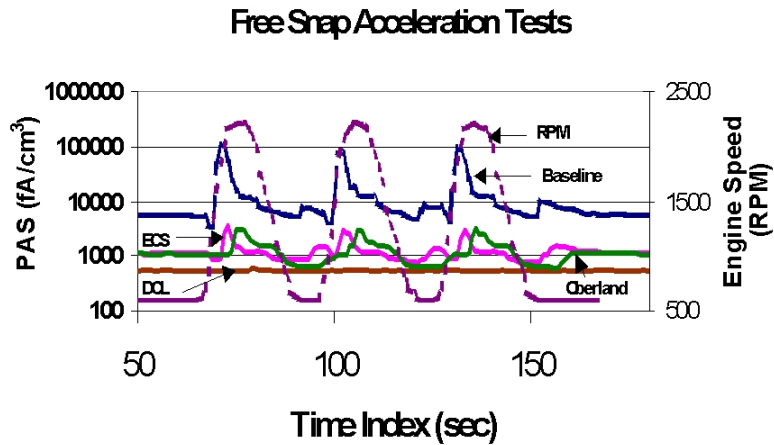
Figure 45 – Results of Measurement with PAS 2000, Snap Acceleration No-Load Tests

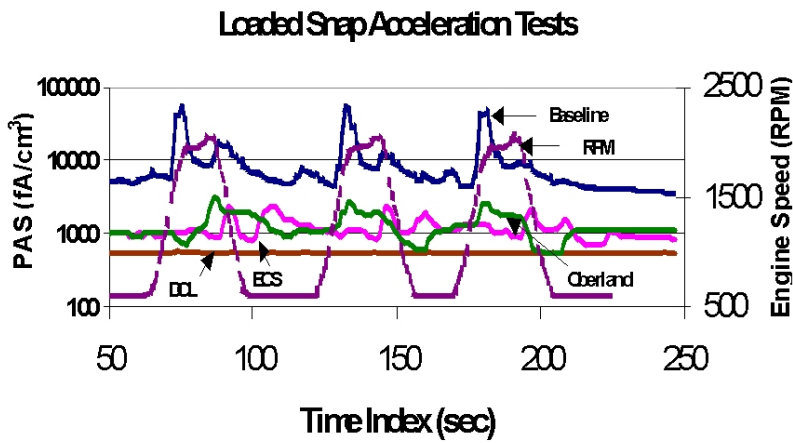
Figure 46 – Results of Measurement with PAS 2000, Snap Acceleration under Load Tests

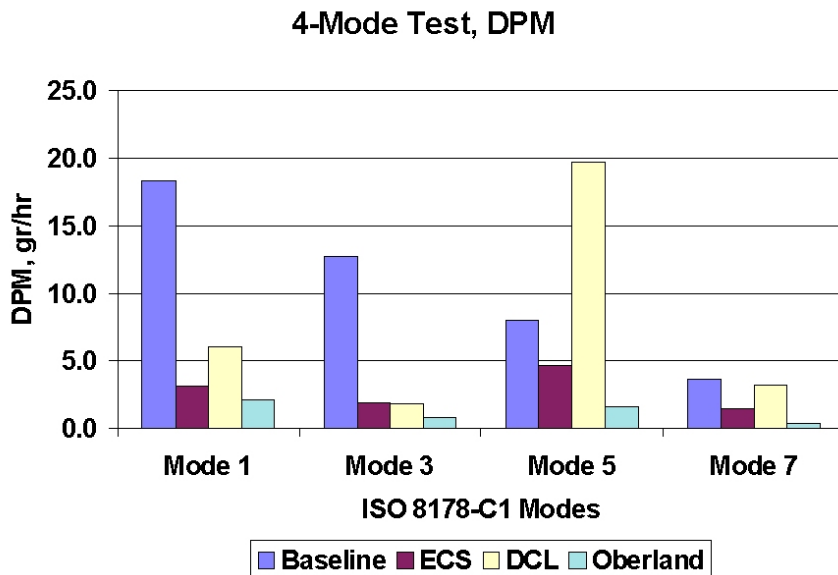
Figure 47 – Average Total DPM Emissions Over Four-Mode Tests

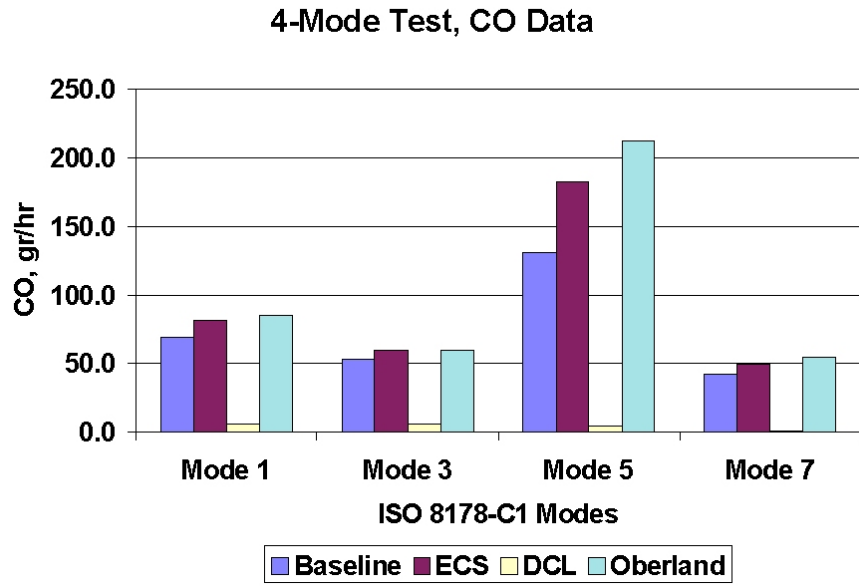
Figure 48 – Average Carbon Monoxide Emissions Measured Over Four-Mode Tests

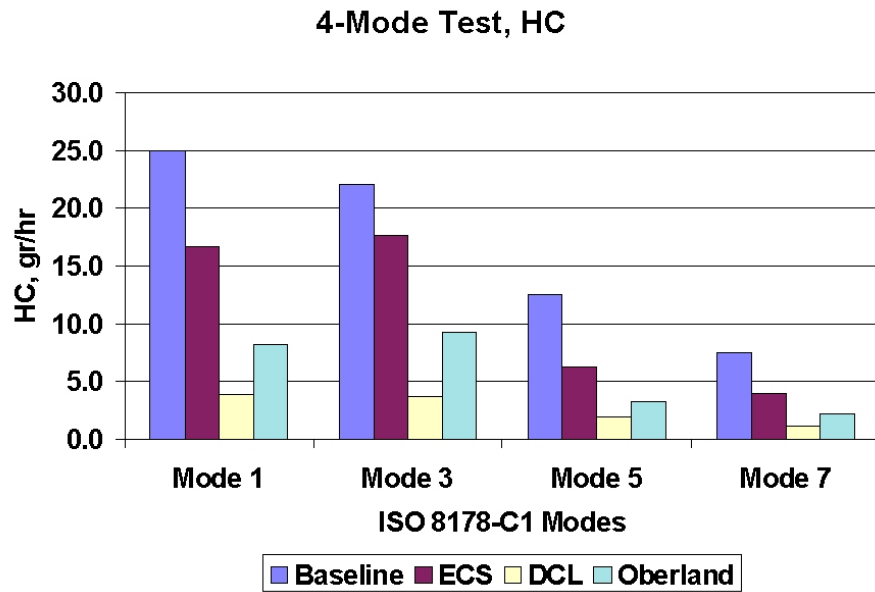
Figure 49 – Average Hydrocarbon Emissions Measured Over Four-Mode Tests

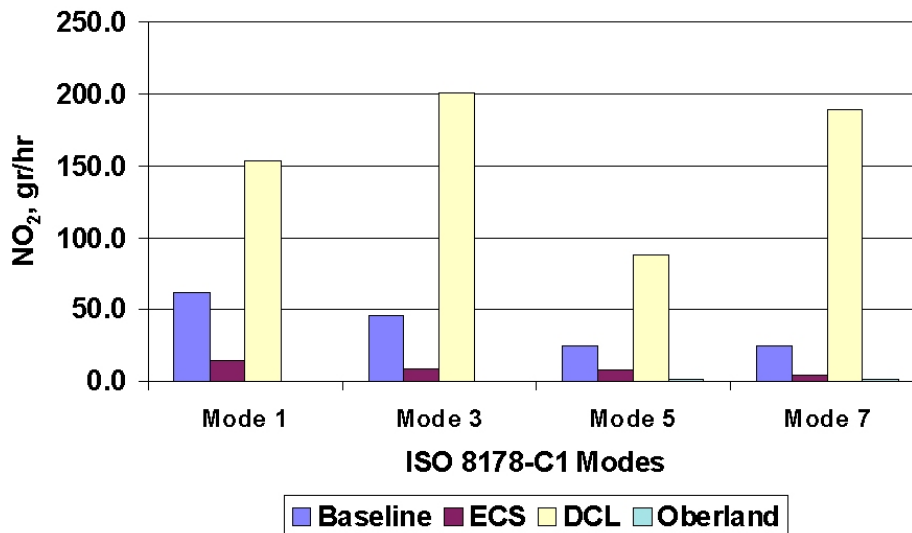
4-Mode Test, NO₂ Data

Figure 50 – Average Nitrogen Dioxide Emissions Measured Across Four-Mode Tests

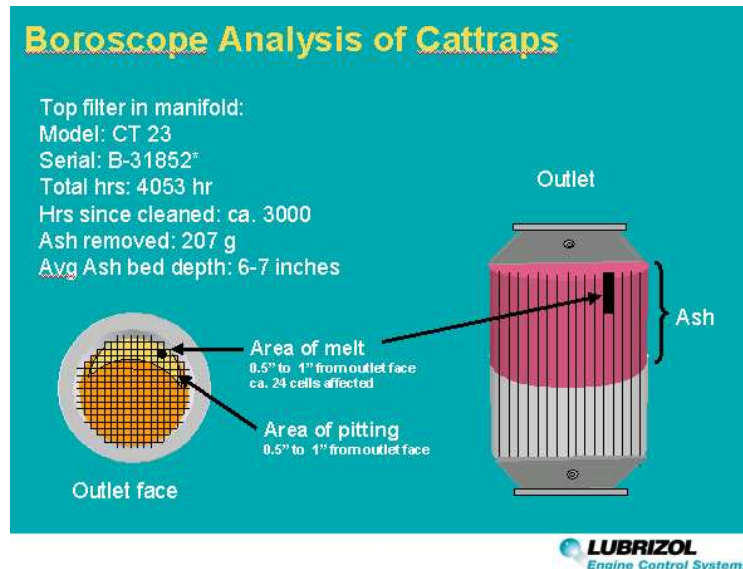
Figure 51 - Non-Destructive Testing of ECS CatTrap

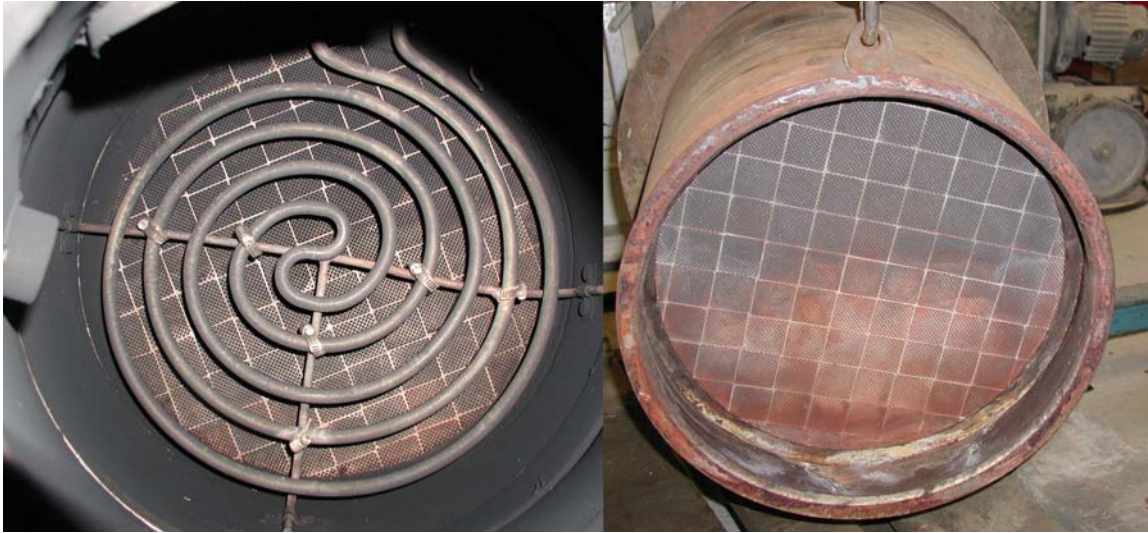
Figure 52 - Inlet and Outlet Faces of DCL Bluesky DPF

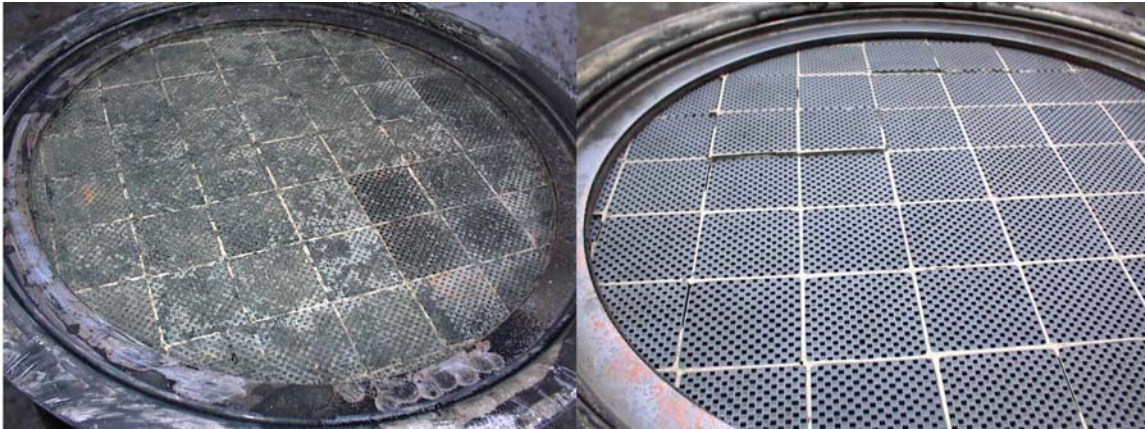
Figure 53 - Inlet and Outlet Faces of ECS Octel DPF

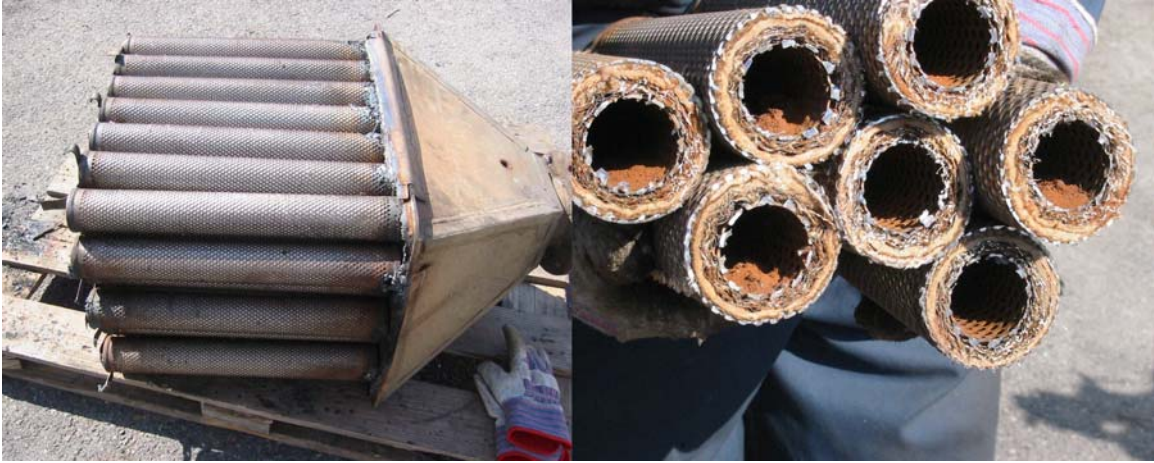
Figure 54 - Oberland Mangold Fiber Cartridges and Iron Oxide Accumulation
