TESTING AND EVALUATION OF AN INFLATABLE TEMPORARY VENTILATION CONTROL DEVICE

Michael A. Trevits, NIOSH, Pittsburgh, PA,

Abstract

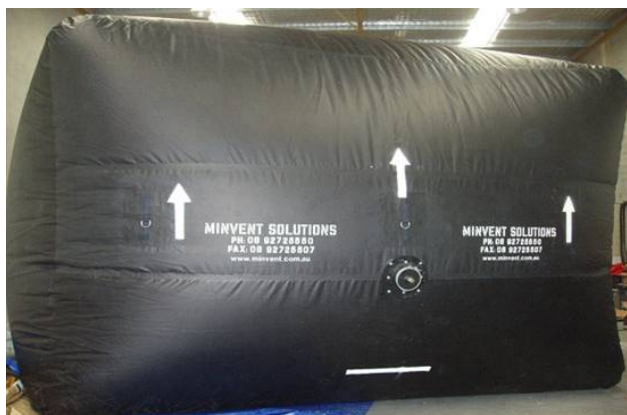
Ventstop®TM is a multi-purpose, inflatable device that is produced by Minvent Solutions and is available world wide for use in the metal and nonmetal mining industry (figure 1). Ventstop®TM is used as an emergency temporary ventilation control device, for controlling ventilation in breakthrough situations, to combat radiation dust, thermal heating return vent, blast fumes and fires. The device can be quickly deployed, is reusable and can be placed in horizontal and vertical mine voids.

Figure 1. Photo of Ventstop®TM

Ventstop®TM was introduced into the Australian Coal Industry in 2005. These units were specifically designed to be placed in strategic areas around a mine for emergency deployment. The original device was a cubed-shaped inflatable structure with square ends (new models for coal mining are cylindrical). The standard unit is constructed from a polyester scrim-based fabric with a double-sided polyvinyl chloride coating (Australia <30 mega ohms NCB Specification 245) and meets the Mine Safety and Health Administration (MSHA) requirements for ventilation materials (MSHA Approval No. 07-BA070011) [1-2].

In general, a Ventstop®TM unit will accommodate entry-width variations of 2 ft and height variations of 3 ft. The unit is typically sized 1 ft larger in diameter than the mine height to ensure the best fit because the surface of mine openings are typically rough and of non-continuous dimensions. Furthermore, if the diameter of the unit is larger than the mine height then mine roof and floor contact area is increased. There is a constraint on length of the Ventstop®TM unit relative to entry width. The unit should be no more than 1-to 2-ft longer than the entry width to minimize the possibility of wrinkling the fabric and thus increasing the potential for air to by pass the unit when inflated. Ventstop®TM is currently available in three standard sizes: 7 ft, 10 ft and 13 ft diameters by 18, 20 and 22 ft lengths (these sizes are designed to fit a maximum 6, 9 and 12 ft high mine opening respectively). It should be noted that a unit can be custom built to any size and shape specification to accommodate any individual application.

Ventstop®TM is completely portable and contains a single chamber that can be inflated from one fill port location by either mine compressed air or bottled compressed air with a venturi or a powered blower. The inflation pressure is very low, on the order of 0.25 to 0.35 psi. The unit can be kept inflated for days using an available filtered pressure demand control system. This system provides a small gas flow to the Ventstop®TM unit to maintain appropriate pressure, and is capable of keeping a unit inflated even when it contains small holes or cuts. Holes or cuts in the unit can be temporarily repaired using a self-adhesive patch, and a permanent repair can be made by welding on fabric patch in fresh mine air.

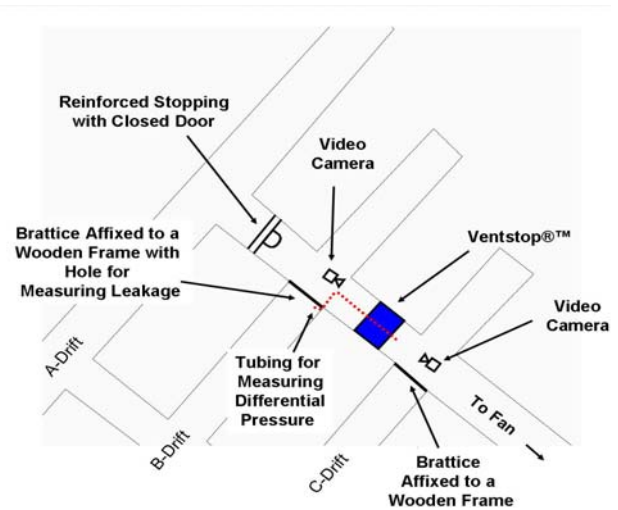
The test area was set-up so that all of the air (and resulting pressure) from the fan would be directed at the Ventstop[®] unit. To minimize air leakage, the intersecting drift openings (B- and C-Drifts) were closed-off using brattice cloth affixed to a wooden frame. To permit differential pressure measurements, 1/4-in diameter tubing was attached to the mine roof across the opening spanned by the Ventstop[®] unit and extended through the nearby downstream brattice cloth and wooden frame structure. This location served as the evaluation point for the tests (figure 4). Air leakage rates were determined using a vane anemometer and the measurements were made at a hole that was cut into the brattice cloth (at the B-Drift intersection) the same diameter as the anemometer. Mathematical calculations were then made to determine the final air leakage rate using the anemometer and differential pressure measurements. Video cameras were mounted on both sides of the Ventstop[®] unit to document the tests.

Figure 4. Layout map of the study area in the No. 1 crosscut of the LLEM.

A series of 4 air leakage tests were conducted to determine the sealing capability and limitations of the prototype Ventstop[®]™ unit. The test area was set up as described earlier and all of the air from the fan was directed towards the Ventstop[®]™ unit (refer to figure 4). A description of the tests, objectives and commentary about the tests are shown in Table 1.

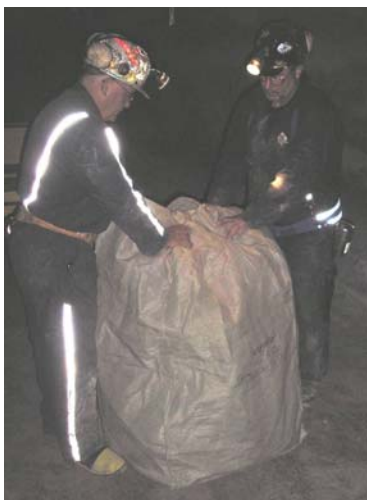
The Ventstop[®] unit used in this study was a prototype constructed of the fire-retardant and anti-static fabric. The unit measured 10 ft in diameter and was 20 ft long and weighed 150 lbs. The Ventstop[®] unit was installed by two persons several times in the mine opening to determine how long it would take to fully deploy the unit. The unit was inflated using mine air and a venturi. On average it took approximately 7.5 minutes to install the unit from the carry bag to full inflation in the mine opening (5.5 minutes to inflate the unit only) (figures 5-6). Deflation of the unit, folding and

Figure 5 – Carry bag for transporting the Ventsop[®] unit.

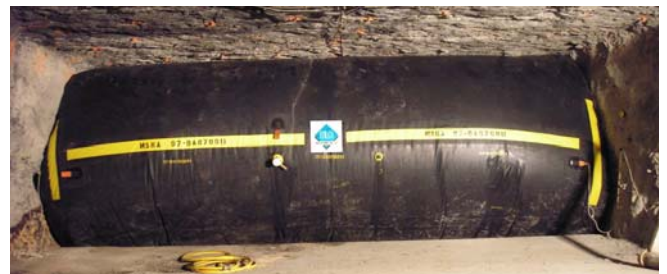
During deployment, adjustments were made to position the unit correctly in the mine opening and to remove wrinkles in the fabric. These adjustments were made by holding the fabric (either at the hold down loop or by clutching the fabric) and moving it to the desired position. This task was relatively easy provided it was done before the unit was fully inflated. If a problem area (such as a wrinkle) was observed after the unit was fully inflated, the problem could be easily corrected by partially deflating the unit, making the adjustments in the fabric and re-inflating the unit. Figures 7 and 8 shows the unit fully inflated in mine opening.

Figure 7. Fully deployed Ventsop[®] unit as viewed from the C-Drift side.

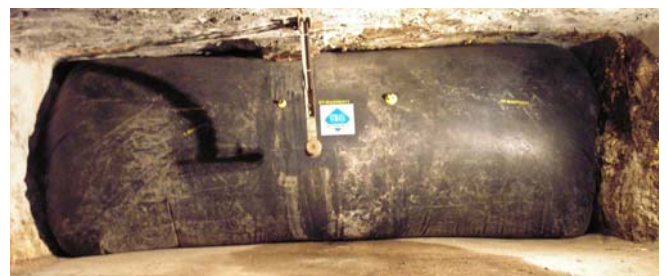
Figure 8. Fully deployed Ventsop[®] unit as viewed from the B-Drift side.

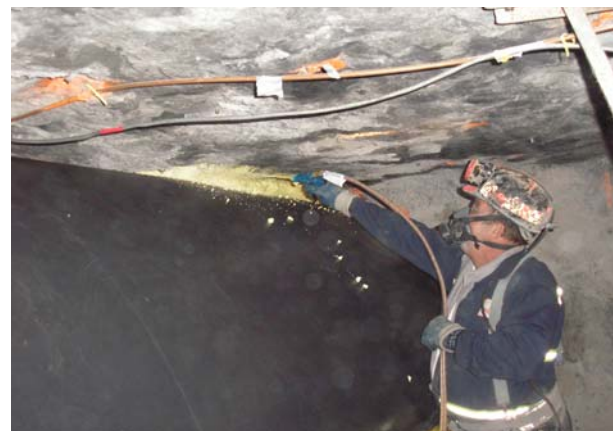
Figure 10 shows the application of a PUR sealant to the upwind side of the Ventstop[®]™ unit as a supplemental means of minimizing mine air leakage. The PUR sealant was sprayed along the entire perimeter at the interface between the Ventstop[®]™ unit and the mine opening. The expanded thickness of the applied sealant was about 5 in and tapered in thickness to 1/8 in at a depth of about of 18 in using the standard spray head provided with the PUR material.

Figure 10. Application of PUR to the perimeter of the Ventstop[®]™ unit.

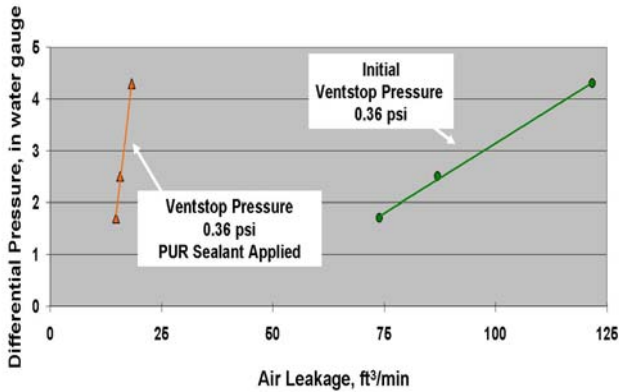
Figure 11 shows the results of Test 2 in which pre- and post-PUR sealant application air leakage tests were conducted. As expected, a dramatic decrease in air

leakage (85%) occurred subsequent to the application of the PUR sealant. Smoke tube testing prior to the PUR application showed that most of the air leakage was occurring near the mine roof and rib interfaces and these air leakage paths were mostly eliminated with the application of the sealant.

Figure 11. Plot of air leakage as observed during Test 2.

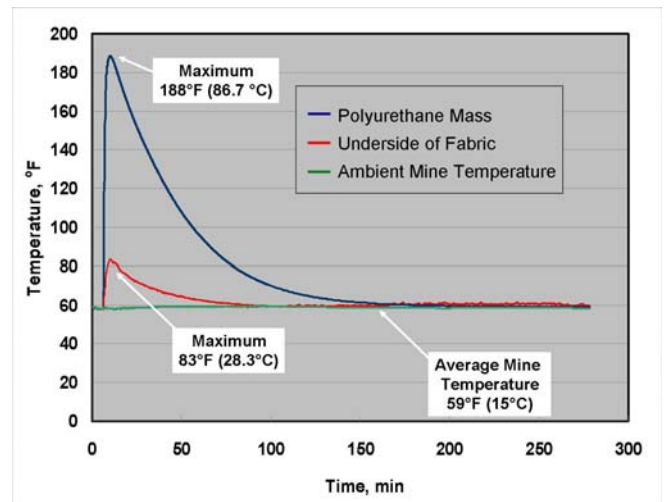
This figure shows that the PUR was applied correctly and the material cured evenly across the test surface. Figure 13 shows the temperature data for this test. It can be observed from the test results that the heat build-up rate was very fast and achieved a maximum temperature of 188°F (well below its auto-ignition temperature). Heat transfer to the underside of the fabric was much less and reached a maximum value of 83°F.

Figure 13. Plot of temperature data for the PUR heat build-up test.

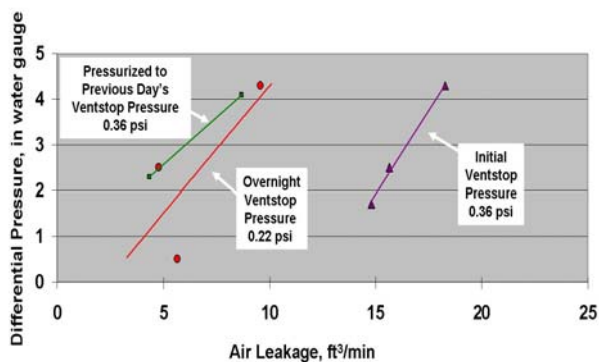
Figure 14 shows the results of Test 3. It is unknown how many times the pressure demand control system was used to re-pressurize the Ventstop[®] structure during the overnight test. When mine air leakage was measured (after 24 hrs), the unit actually leaked less air at the lower inflation pressure (0.22 psi). Furthermore, when the unit was re-pressurized to the previous day's pressure setting (0.36 psi), the unit leaked less air than the day before. It is thought that the re-pressurizing cycle (or cycles) caused the Ventstop[®] structure to seat more tightly in the mine opening and thus leak less air as observed in the test. It should also be kept in mind that these air leakage rates are very low, approaching the limits of the measuring method and may not be completely accurate.

Figure 14. Plot of air leakage as observed during Test 3.

Air leakage Test 3 involved a 24 hr inflation test with use of the pressure demand control system. This system was designed to maintain a set inflation pressure on the Ventstop[®] unit. An air leakage measurement was made at the beginning of the test (at 0.36 psi inflation pressure) after the PUR sealant was applied and 24 hrs later at the maintenance pressure of 0.22 psi. The unit

was then inflated to 0.36 psi (the original inflation pressure) and another air leakage measurement was made.

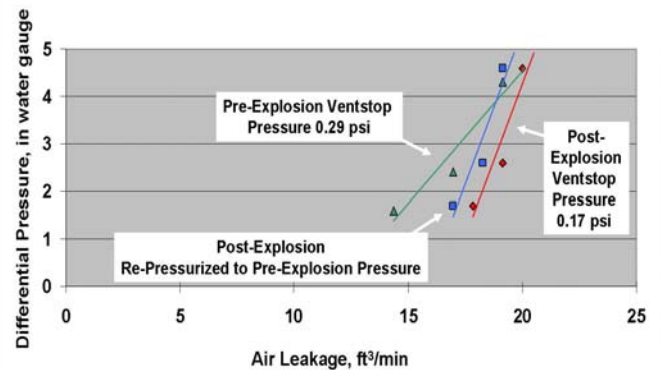
Air leakage Test 4 was carried out while a methane gas ignition test was being conducted at a different part of the mine. The Ventstop[®] unit was approximately 1,250 ft from the A-drift ignition zone. The pressure pulse from the ignition traveled through the A-Drift, crossed into the B- and C-Drifts and then was applied to the Ventstop[®] unit at two slightly different times due to travel distance. Pressure transducers were placed on both sides of the Ventstop[®] unit to capture the magnitude of the pressure pulse. Based on the B-Drift pressure data, the Ventstop[®] unit was subjected to an initial peak positive pressure (after some oscillations) of about 0.08 psi, followed by a peak negative pressure of about 0.25 psi, then another peak positive of about 0.15 psi followed by a peak negative of about 0.1 psi; this oscillation continued until the end of the 12 second data acquisition time. Based on the C-Drift pressure data, the Ventstop[®] unit was subjected to an initial peak positive pressure of about 0.45 psi, followed by a peak negative pressure of about 0.65 psi, then another peak positive of about

0.5 psi; at that point, the 12 seconds of acquisition time ended. The peak sweeping pressure value appears to be in the 0.5-0.6 psi range [5]. Upon visual inspection, the Ventstop[®] unit appeared to be intact. Figure 15 shows the results of air leakage tests conducted before the ignition, 1 day after the ignition (the unit had lost 0.12 psi) and then when it was re-inflated to the pre-ignition conditions. The data on the plot suggests that no significant change in air leakage occurred as a result of the ignition.

Figure 15. Plot of air leakage as observed during Test 4.

The Ventstop[®] unit was also subjected to the oscillating pressure pulses from a methane gas ignition. Though the ignition zone was approximately 1250 ft away and the resulting pressure pulse degraded as it traveled through a series of drift openings to the Ventstop[®] unit, it successfully withstood a maximum peak positive pressure pulse of 0.5 psi and maximum peak negative pressure pulse of 0.65 psi and a peak sweeping pressure value in the 0.5 to 0.6 psi range. Pre-and post-explosion tests show that the air leakage past the Ventstop[®] unit was not affected by the forces of the pressure pulses.

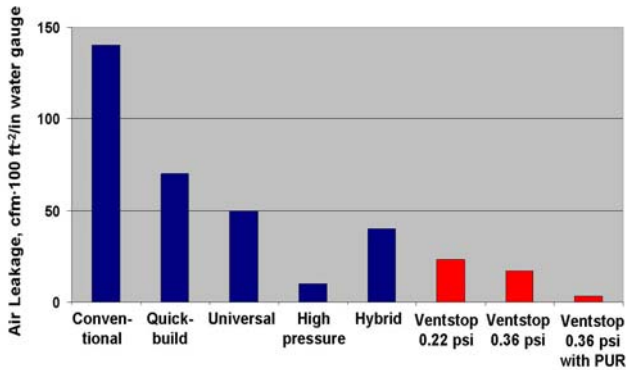
In a study conducted by the US Bureau of Mines (USBM), five different stopping construction techniques were evaluated and air leakage tests were performed [6]. The stoppings studied included conventional stoppings that were built by dry-stacking hollow-core concrete blocks and troweling mortar on one stopping face; quick-build stoppings that were built in the same manner as conventional stoppings except brushed-on glass-fiber enhanced mortar (modified mortar) was substituted for troweling; universal stoppings that were built of dry stacked hollow-core blocks, had a footer, keyed ribs, sealed roof and one face sealed with one coat of modified mortar; high-pressure stoppings that were built of hollow-core wet-laid concrete blocks, had a footer, keyed ribs, a sealed roof, two brushed-on coats of modified mortar on one face and one coat of brushed-on modified-mortar on the other face; and hybrid stoppings that were built the same way as high-pressure stoppings, except that solid-core blocks were used instead of hollow-core blocks. Figure 16 shows a comparison of the leakage rates for Ventstop[®] at 0.22-, 0.36-psi and 0.36-psi inflation pressure with PUR applied from this study with the other types of newly constructed stoppings from the USBM

study. Also for comparative purposes, the air leakage rates were converted to cubic feet per minute per hundred square feet of stopping area per inch water gauge pressure differential [6]. As can be observed in the figure, the air leakage rates for the Ventstop[®] unit were among the lowest leakage rates observed. Also, the leakage rate for the Ventstop[®] unit with PUR applied was the lowest rate measured.

Figure 16. Air leakage for various newly constructed stoppings and Ventstop[®].

Comparison of air leakage rates for Ventstop[®] at 0.22-, 0.36-psi and 0.36-psi inflation pressure with PUR applied from this study with the several types of newly constructed stoppings from a previous USBM study showed the air leakage rates for the Ventstop[®] unit were among the lowest rates observed. Also, the leakage rate for the Ventstop[®] unit with PUR applied was the lowest rate measured.
