# Regional Bumps: Case studies from the 1958 Bump Symposium

J. Whyatt, National Institute for Occupational Safety and Health (NIOSH), Spokane Research Laboratory (SRL), Spokane, WA

## I. Abstract

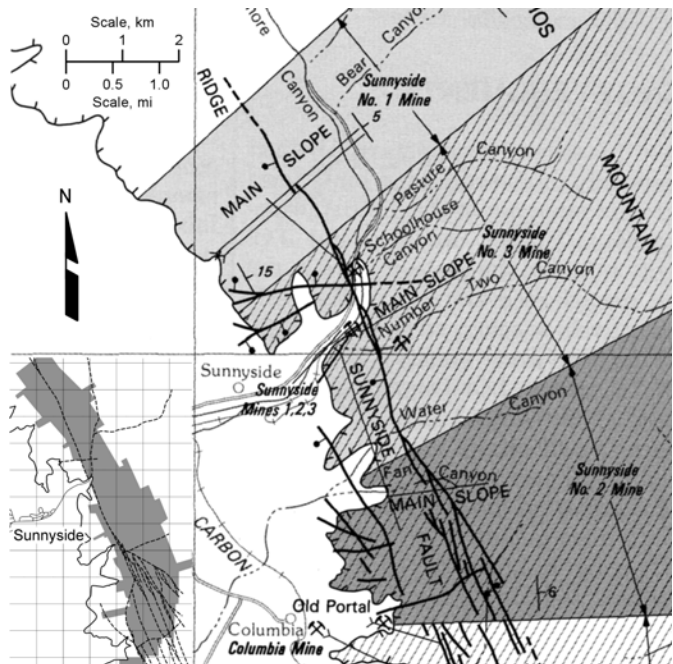
**Figure 1** The main Sunnyside fault zone in the Sunnyside 1,2 and 3 Mines (after Osterwald, 1993). Inset is a map of mining to 1958. Shaded area is 4 sq. miles of worked out or first mined coal seam (after Peperakis, 1958).

The Sunnyside fault lies along a roughly 3.5 mile southeast trend, subparallel to the strike of bedding with displacement reported to be 30 ft (Clark, 1928). Osterwald et al (1993) report on more recent mapping of the northwest-trending Sunnyside fault zone (figure 1). They describe the fault zone as follows:

“... a belt of fractures about 1930 m (1.2 miles) wide in the southern part of the [Sunnyside] district, but it narrows to a single break in the northern part of the district. It dips almost vertically, and the stratigraphic separation across the zone is commonly about 9 m (30 ft). The southwest side is downthrown.”
