# **Worker Deaths by Electrocution**

## **A Summary of Surveillance Findings and Investigative Case Reports**

# **WORKER DEATHS BY ELECTROCUTION**

**DHHS (NIOSH) PUBLICATION No. 2000-115**

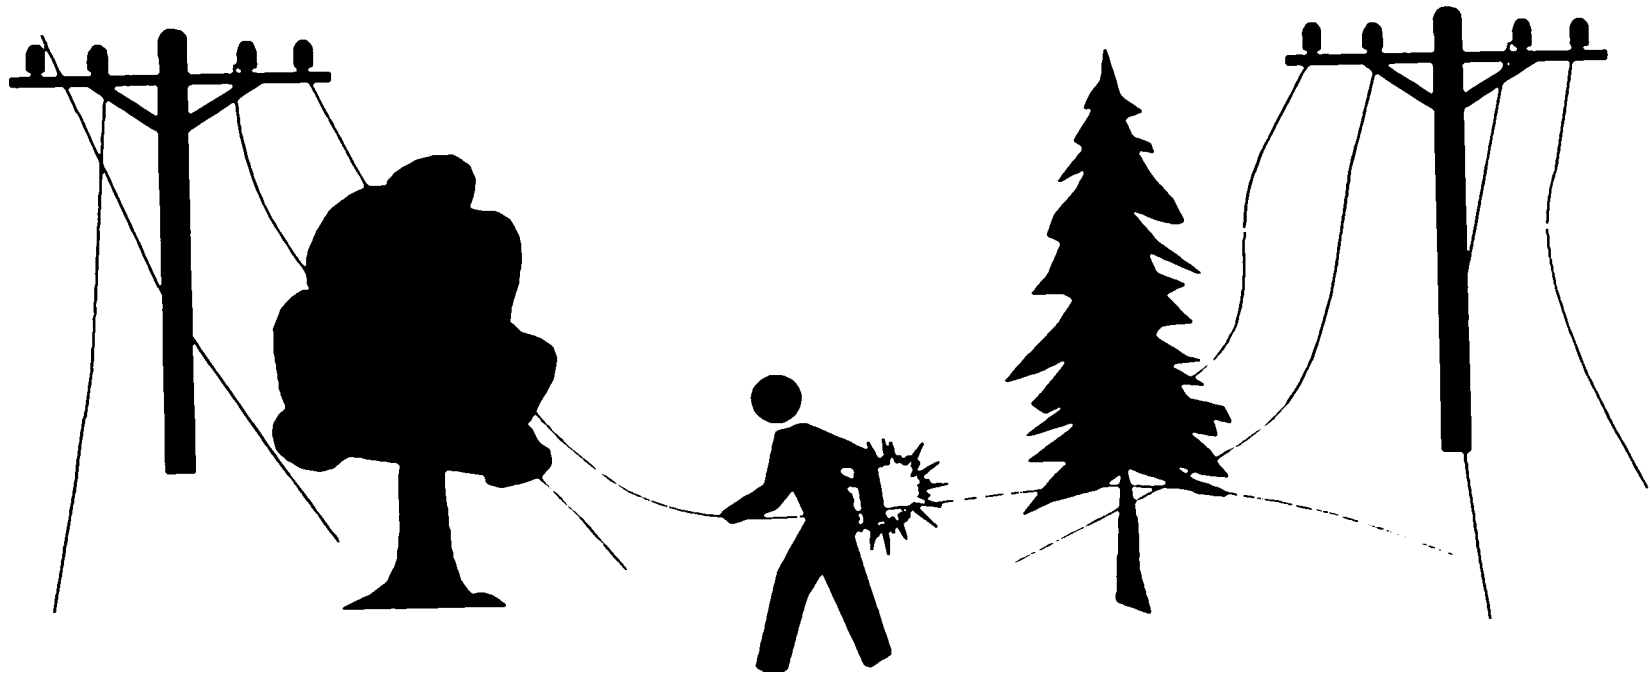
**Figure.** *Tree Trimmer Electrocution*
